Pickling and Passivating of Corroded Tanks on Chemical Ship

No 4/2011

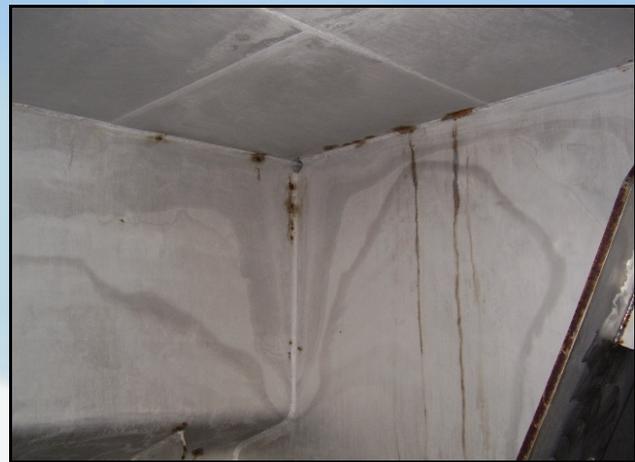
Some of corrosion damages were serious ones that could bring catastrophic effects. Several fragments of the welds were completely rusted; some of them joining plates at the tank ceiling, the other joining walls with the ceiling. Several fragments of the welds were completely covered with rust or a number of rust spots were over or around the welds between the tank ceiling and the walls. Corrosion of plate welds is the most dangerous problem as regards tank tightness. Rust was located mostly around the welds at some distance but in some cases close to the welds. When electrochemical potentials were checked it was found that a few weld segments with the potentials after passivation below 600 mV presented improper welding material quality (Fig. 1).

Fig. 1. Rust left after passivation shows improper weld fragments

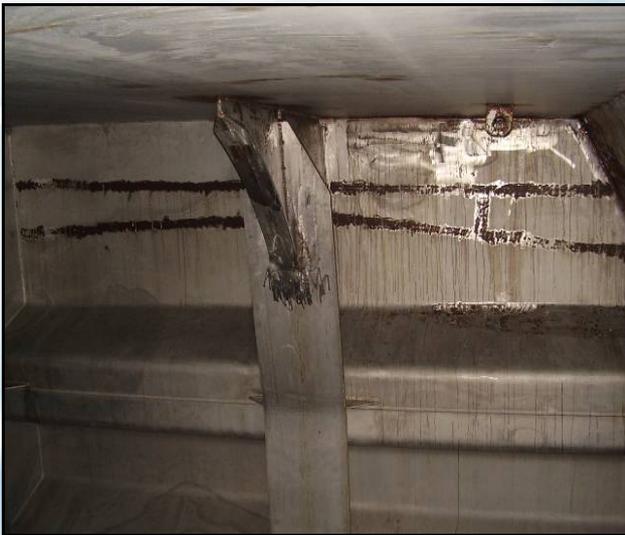
Corrosion around welds of eye pads, rust stains over top of the walls and over the ceilings in all tanks (15% of the surface covered with rust in the most corroded tank) and some small pits were present. Single shallow pits were under rust spots in places that were heavily ground. Overheated strips after welding supporting elements from external side of transverse corrugated bulkheads started to rust. Thick rust strips at the internal bulkheads were up to 100 mm wide (Fig. 2-3).

Fig. 2. Strips of rust from coming from outside supports welding

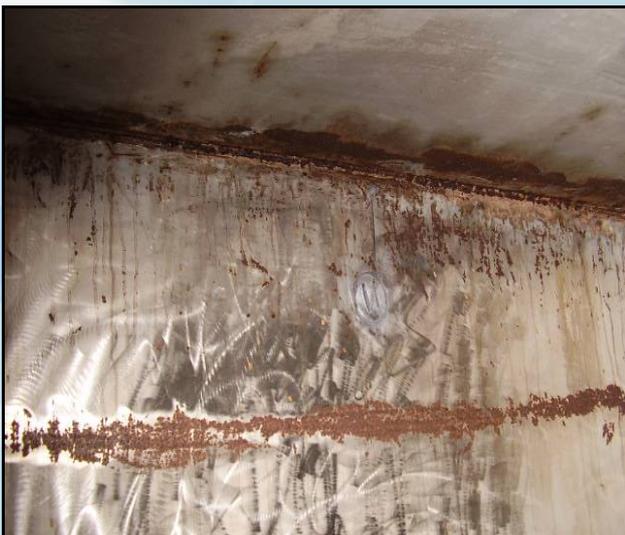
Fig. 3. Rust over weld and strip of rust from outside welding

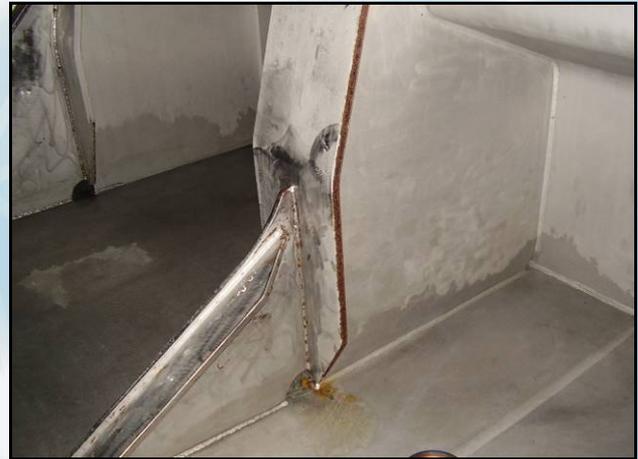
The edge sides of nearly all vertical, bottom or ceiling stiffeners were covered with heavy rust spots (Fig. 4) being a result of improper cutting technology. These edges under rust were smooth. In many cases rust was concentrated at one edge side of the stiffeners. At some stiffeners weld slugs were over welds. The large surfaces of the stiffeners were with no rust at all.

Fig. 4. Rusted edges of supports

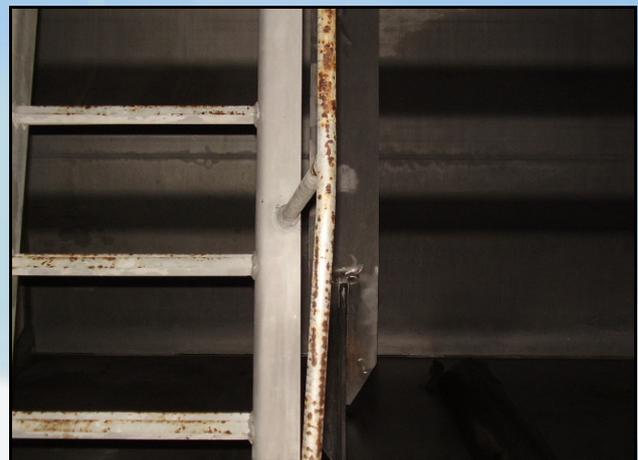
Most of the ladder steps were covered with small rust spots coming obviously from imbedded iron external contamination that came through open manholes. All the railings were covered with small rust spots (Fig. 5).

Fig. 5. Rust on ladder steps and railings coming from embedded iron
