Pickling and Passivating of Petroleum Tank in Norway

No 3/2010

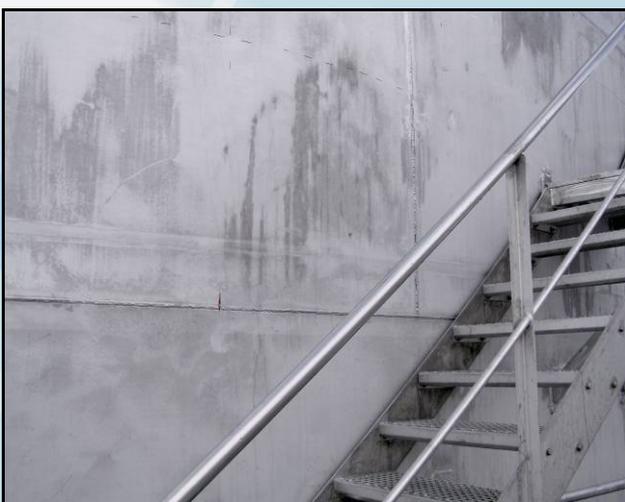
At the beginning two workers went to Kollsnes by air to make tests. They found nearly the whole tank surface covered with spots usually showing a vertical direction (Fig.1). After choosing reference surfaces the Ancora workers tried a few preparates of Avesta Welding Chemicals with brush application (Fig.2).

Fig. 1. Most of the spots on tank surface showed vertical direction

It was stated that surface contaminations could no be removed by chemical means so that it was advised to clean the surface with glass bead blasting. A trial brought data on effectiveness of the applied staffs and allowed to select proper preparates to use after blasting (Fig.3).

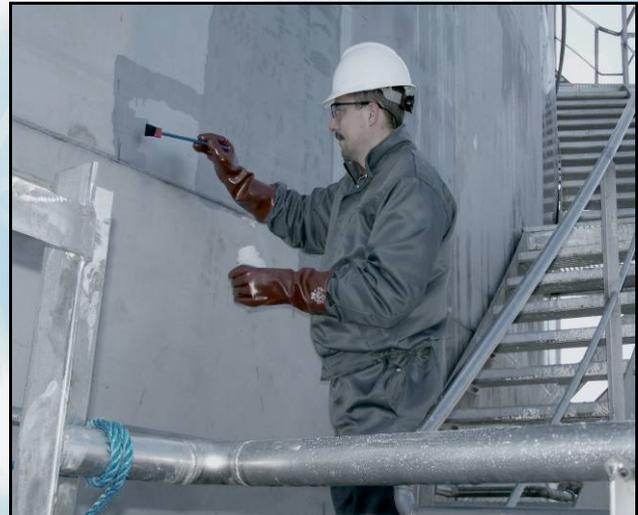
Fig. 2. Field testing of effects after application of varied Avesta pickling preparates

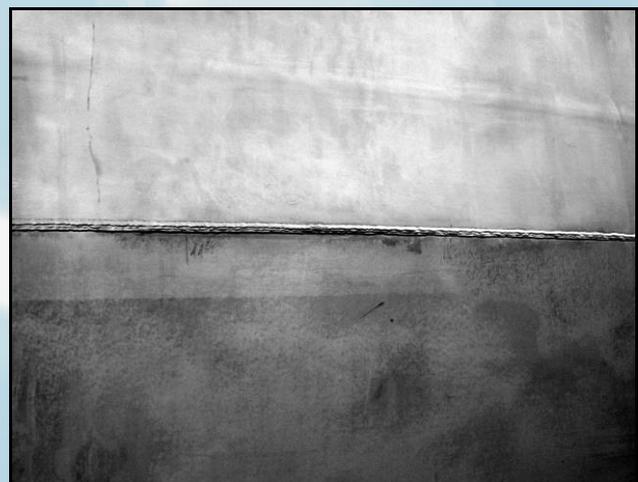
Fig. 3. Differences at treated (top of the picture) and no treated surfaces after brush application of chemicals

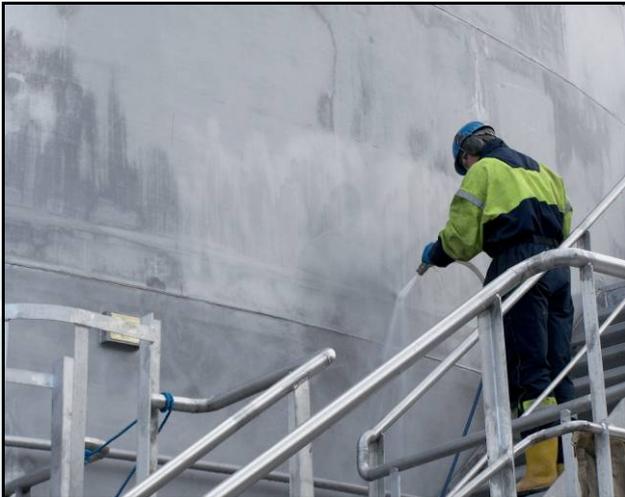
Fig. 4. Tank surface was flushed with water and dried before pickling/passivation

To carry out pickling/passivation at the second step a team of four workers went to Norway by car with the equipment and the chemicals. At the beginning of the second step the outer tank surface was carefully washed before Ancora Co. started pickling work (Fig.4). The work was carried out by spraying Avesta chemicals from a lift platform (Fig.5).

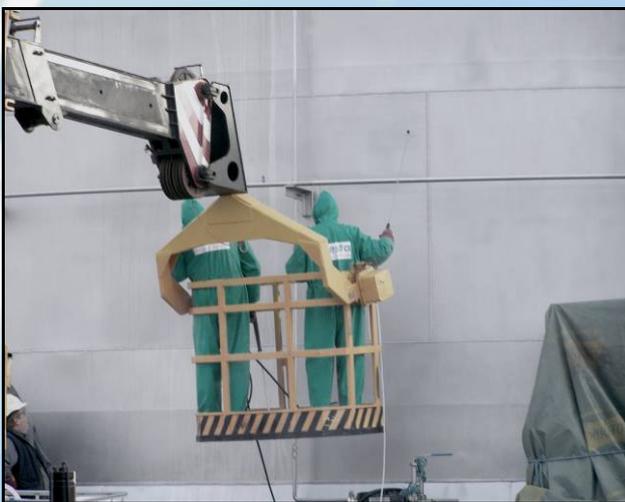
Fig. 5. Pickling/passivation of tank outer surface performed by spraying

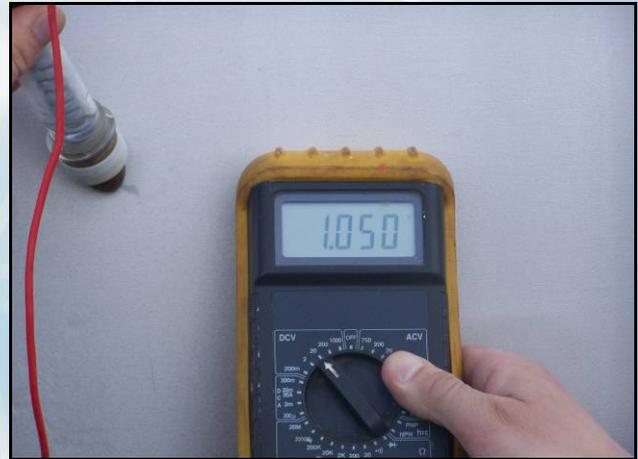
pickling and passivation so that Ancora workers had to work during night shifts as another time was occupied by the construction teams. In 8 days the work was completed, electrochemical potential tests were done (Fig.6) and a final certificate was issued.

Fig. 6. Passivation effects were controlled by electrochemical potential measurements

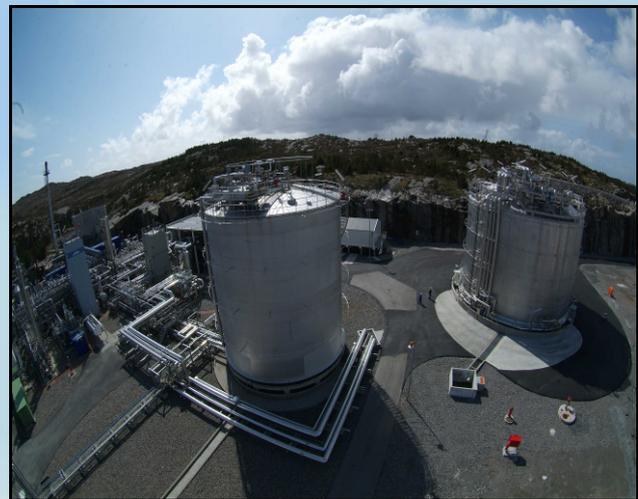
The work was accepted by the Gasnor representatives who were much satisfied as the tank was finished in time, before the planned prime minister visit (Fig.7).

Fig. 7. Tank ready for exploitation before prime minister visit ¹
