- *Construction corrosion of poultry meal production hall*

INTERIOR METAL CONSTRUCTIONS

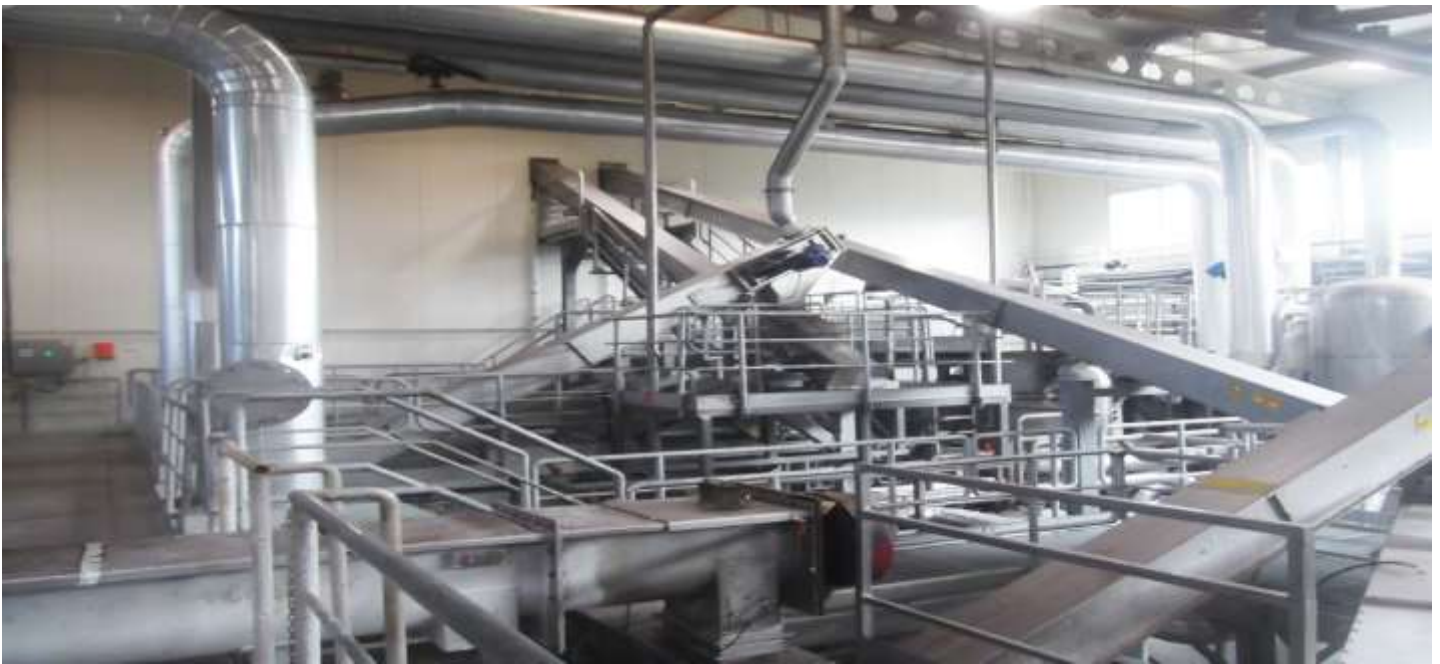
Fig. 1. Galvanized steel constructions in the Production Hall contaminated with poultry meal were free from rust. Aluminium mantels over piping was with no corrosion signs.

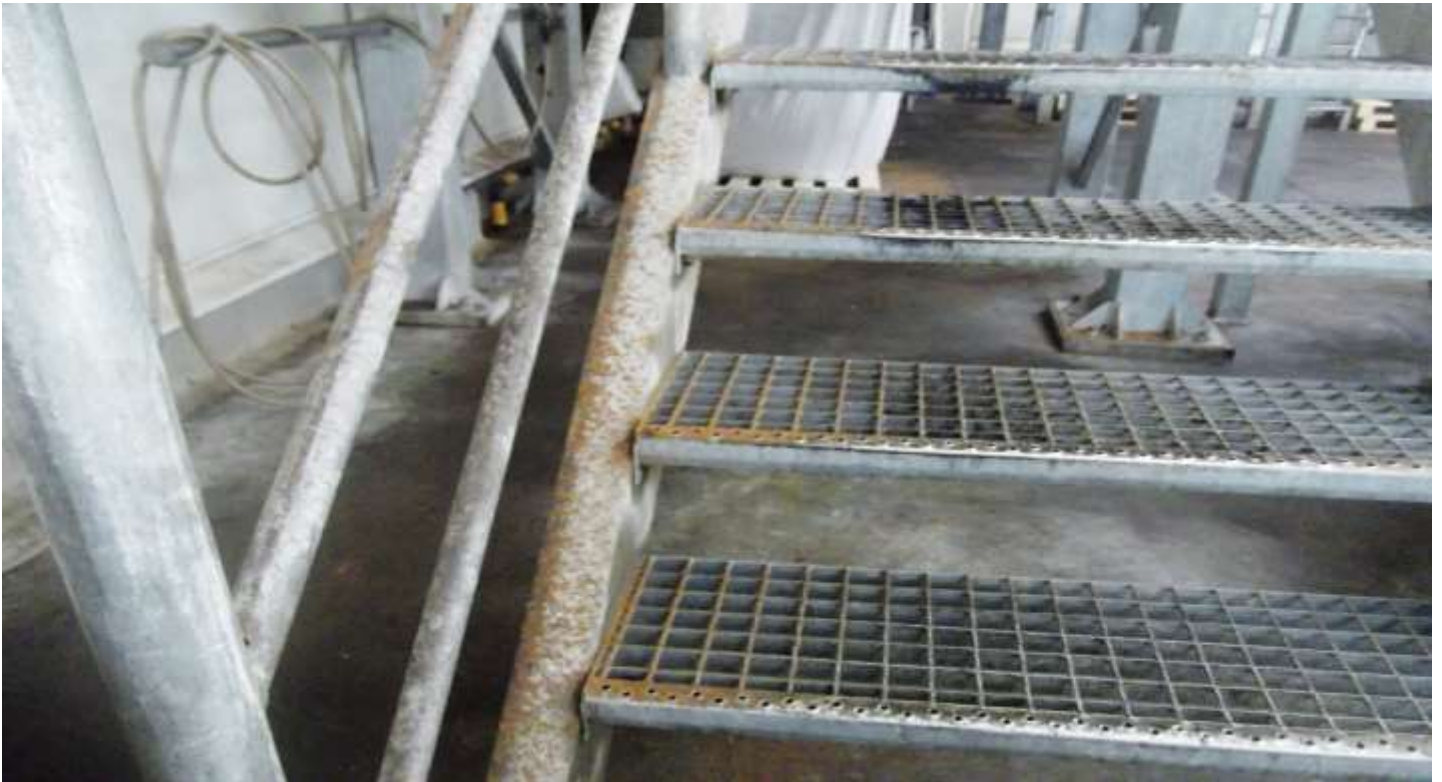
Fig. 2. Poultry meal deposited on the galvanized steel constructions can not be easily differentiate from iron rust.

Steel without zinc coating, or steel re-welded was attacked by uniform corrosion. Locally deposited poultry powder can not be easily differentiate from iron rust. Deposited powder can be removed with hard brush. Rest of the powder can be removed with wet mops. Removal of rust requires wire brushes. In the case of doubts the deposited zinc coating thickness can be measured using magnetic probe or rust can be identified by ferroxyl test (with potassium ferric cyanate).

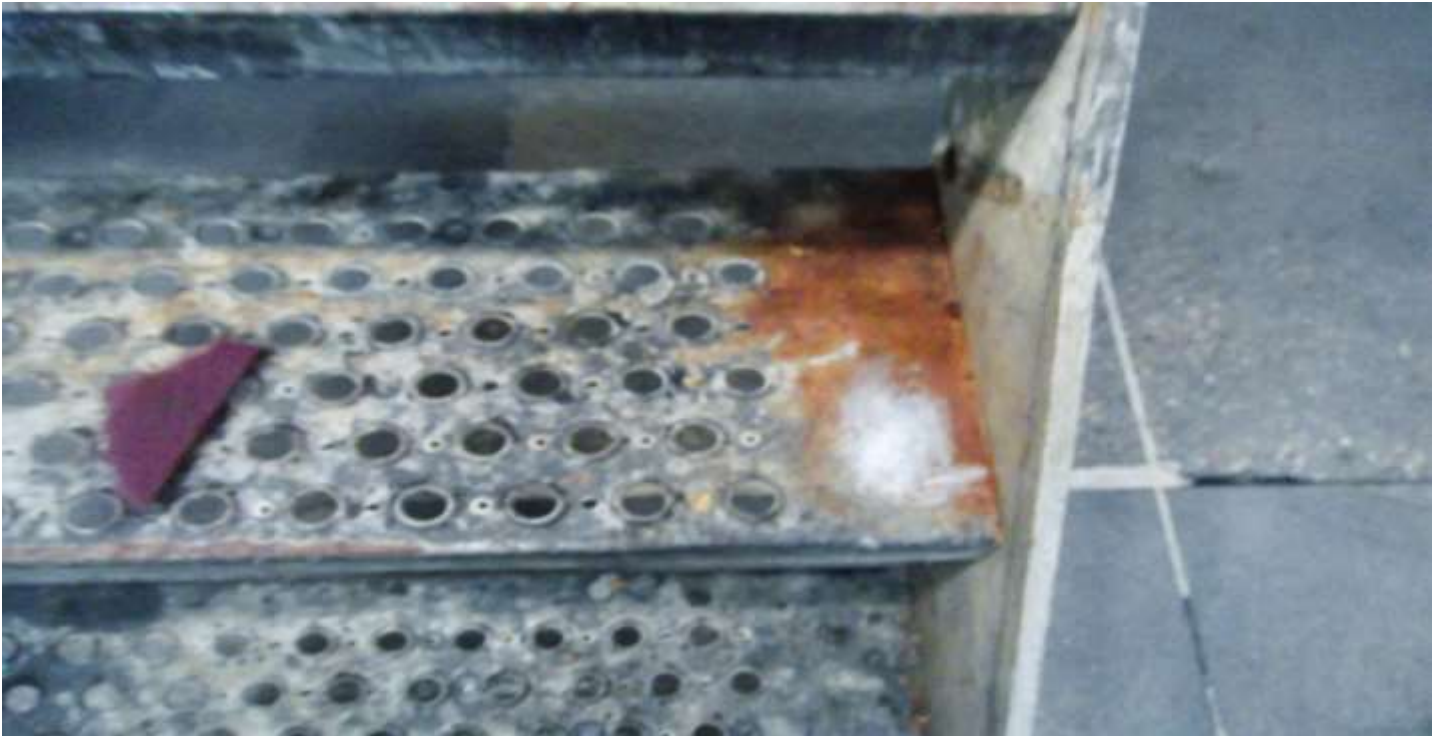
Fig. 3. Coating thickness test performed after removal of strongly adhering deposit showed that zinc film thickness was with no change.

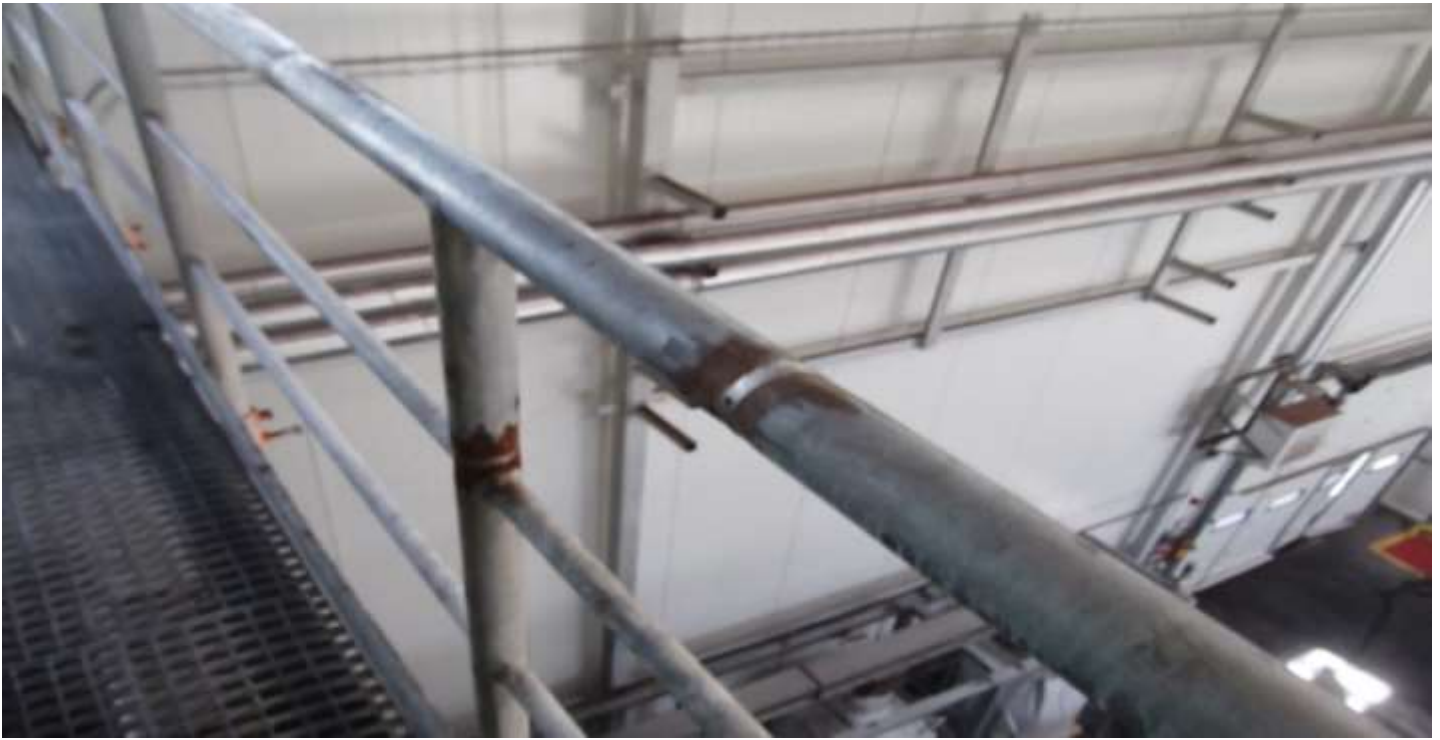
Fig. 4. There were few places on the constructions, for instance after re-welding, covered with rust. Renovation after mechanical cleaning should be done with a paint loaded with zinc dust..

Corroded construction elements in aggressive gas stream required renovation of the protective coatings. Rusted galvanized construction elements should be cleaned using electric drive steel brushes and washed with water containing a detergent. They should be protected with two layers of a paint having high content of zinc dust, applying brushes with a short bristle. Rusted steel screws should be exchanged to galvanized ones or cadmium covered, because the latest have better corrosion resistance.

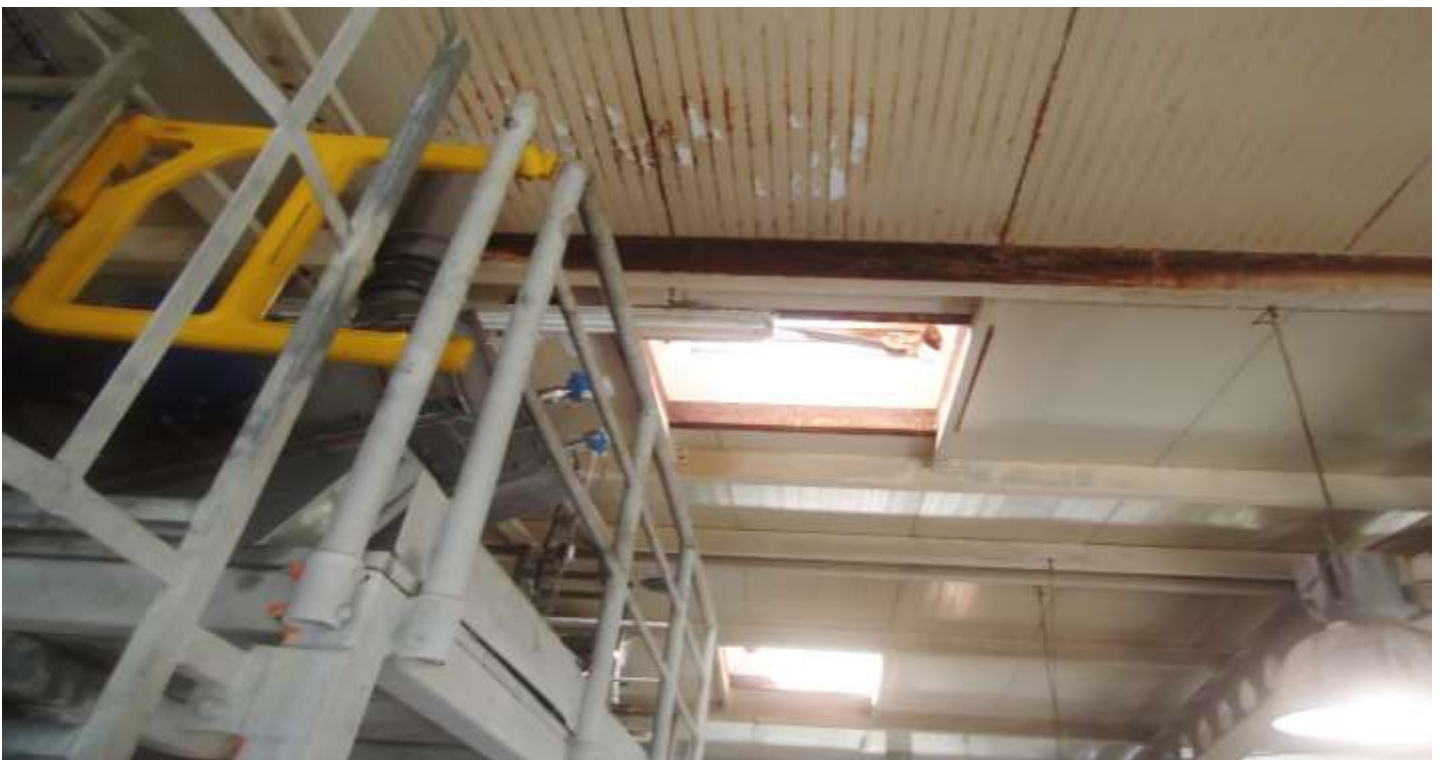
Fig. 5. Corrosion of construction elements including sandwich panels consisting of hard mineral wool core covered with galvanized and painted steel plates rusted within the flow stream of aggressive gases.

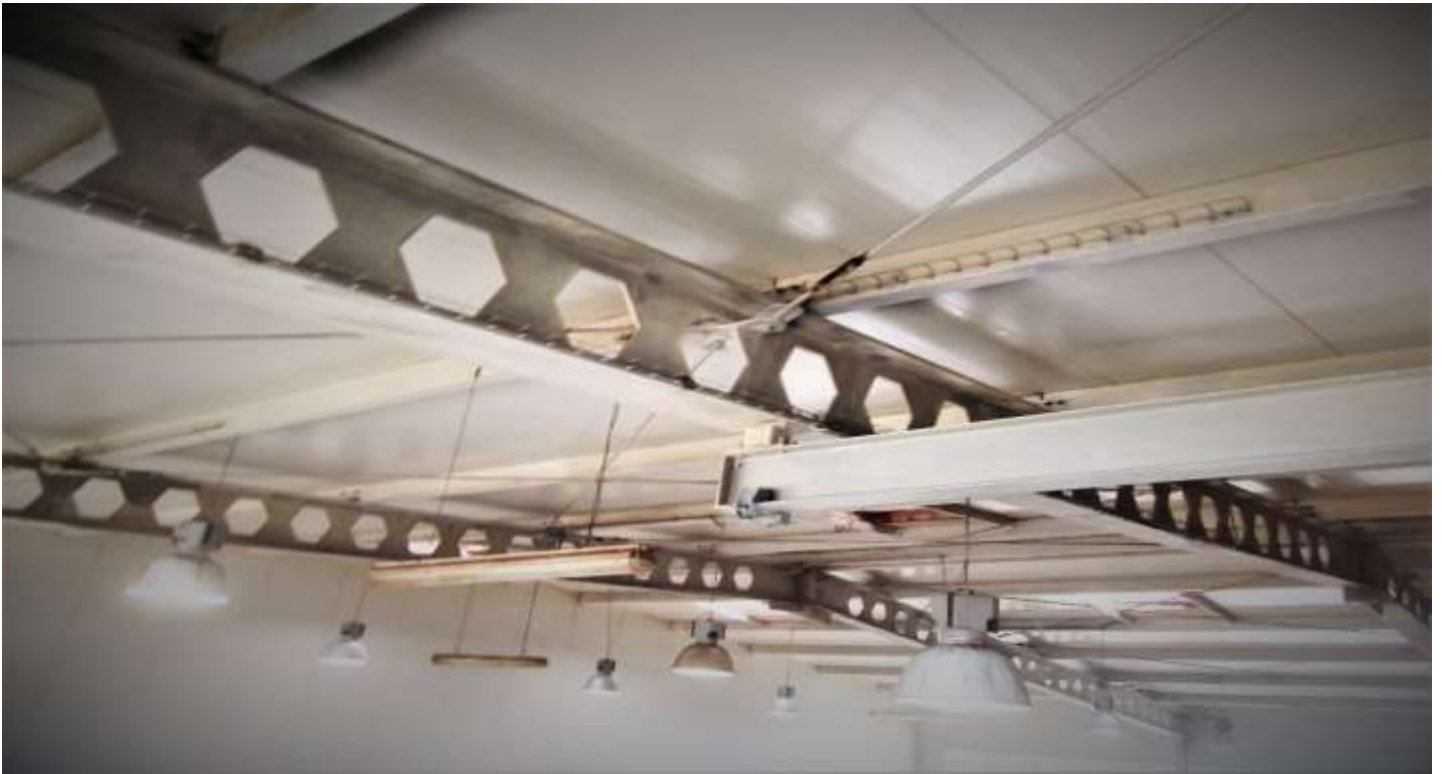
Fig. 6. Threat of corrosion cracking of rusted steel rod threaded parts due to continuous stress.

It was advised to check condition of the coatings on the construction elements under the ceiling at 2-3 years intervals. There was a danger of the stress corrosion cracking of rusted steel rods so that corroded surfaces should be cleaned without delay and protected with a paint loaded with zinc dust. To avoid difficult work at a height these elements should be exchanged to ropes or rods of stainless steel.

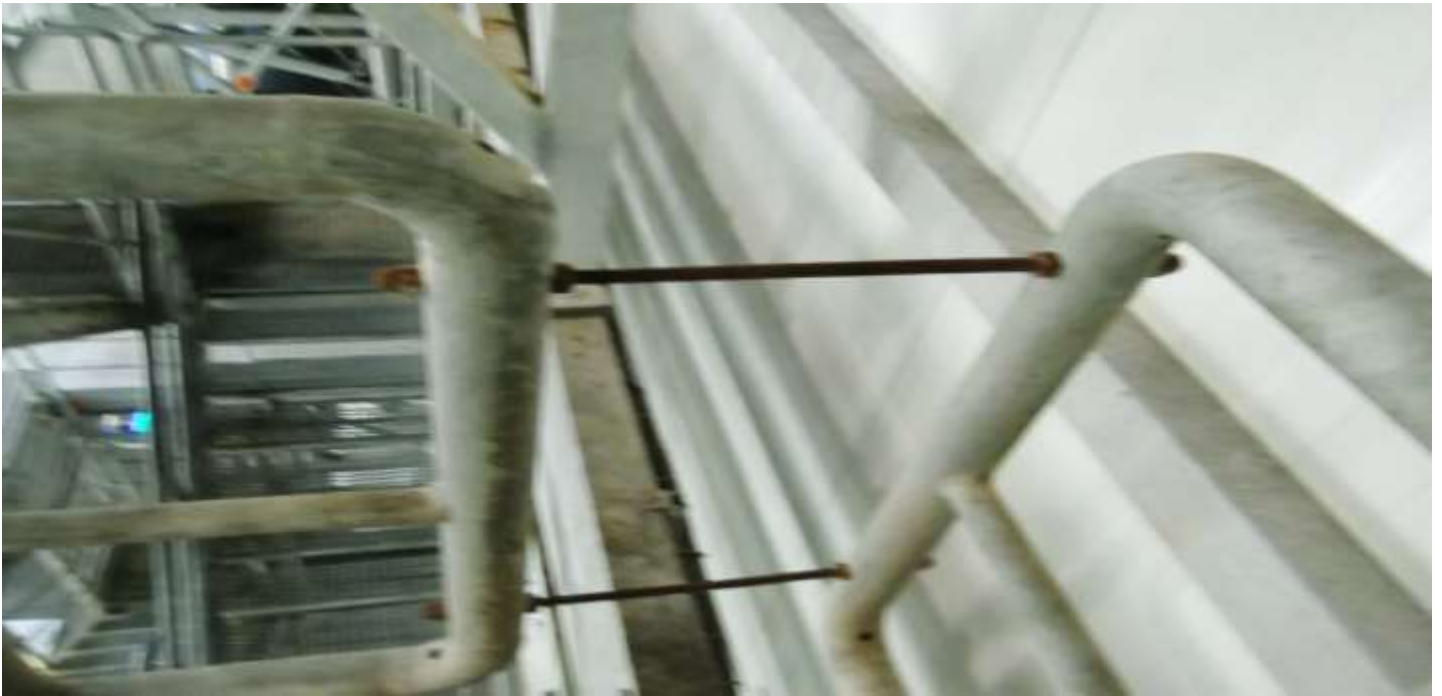
Fig. 7. Rusted rods without protective coatings may be affected by stress corrosion cracking.

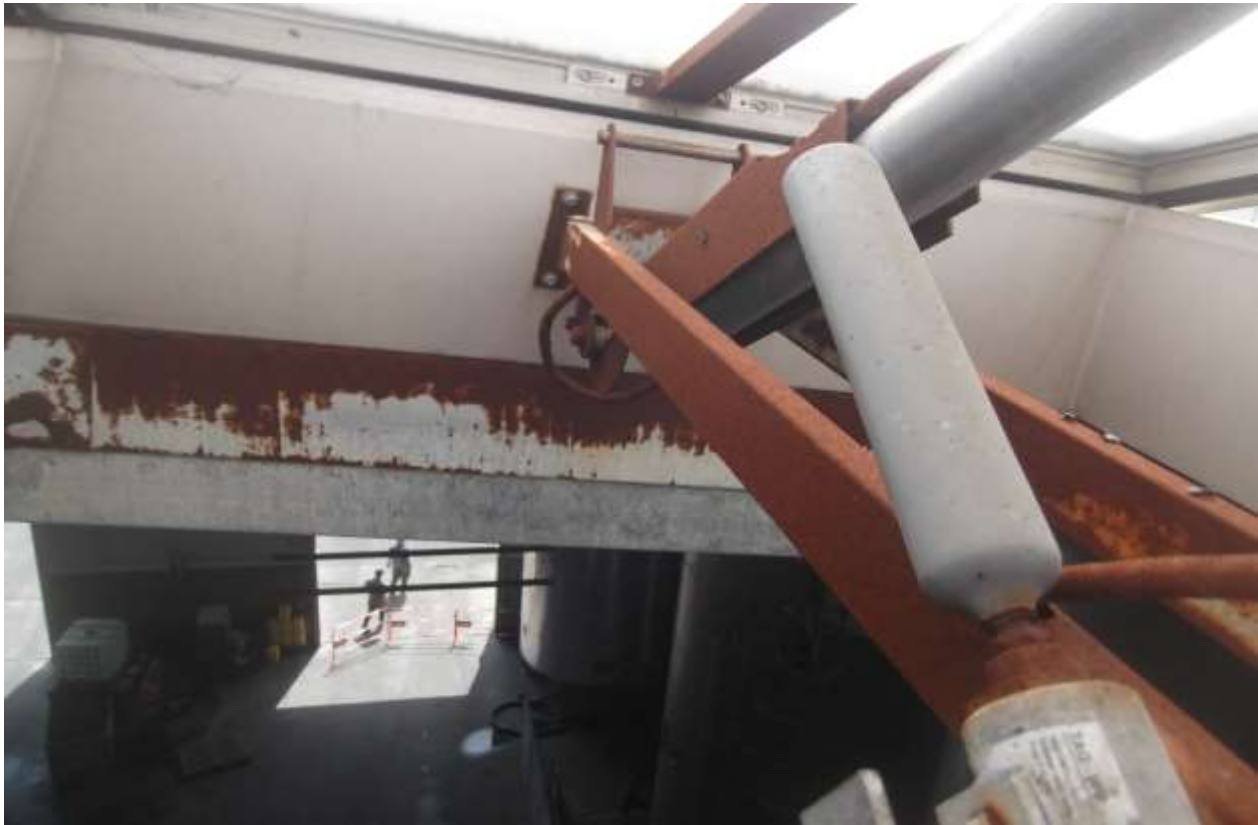
Rooflight domes with pneumatic opening system were installed on the flat roof of the hall. Construction elements were protected with a paint coating having thickness around 30 μm . The thin paint film did not protect steel against humid warm outgoing gases and external atmospheric conditions. Many internal metallic surfaces of the rooflight dome bases had the paint coating damaged partly or completely. On rooflight dome surfaces having nearly full damage of the protective coating a thick layer of rust was formed. A number of construction elements used for opening the domes were rusted. Some of the dome glasses were broken. Pneumatic actuators and upper frames were made from corrosion resistant material.

Fig. 8. Elements of dome rooflights with pneumatic locking, used for ventilation, were intensively corroded after 4 years at the Production Hall roof.

The corroded rooflights above the Production Hall should be exchanged the ones durable within the aggressive gas streams. Roof flashings around the rooflights, domes having broken glass and rusted steel sheets on the roof should be exchanged.

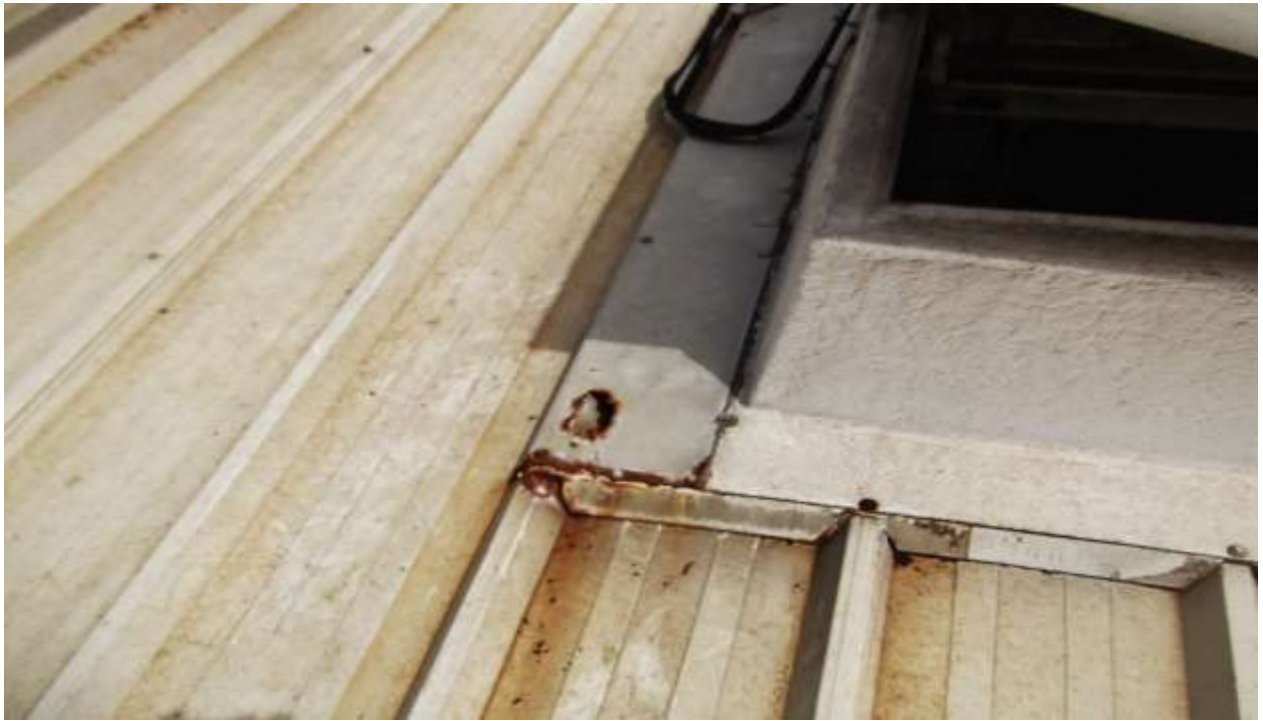
Fig. 9. Rust at connections between rooflights construction and sandwich panels after 4 years on the Production Hall roof.

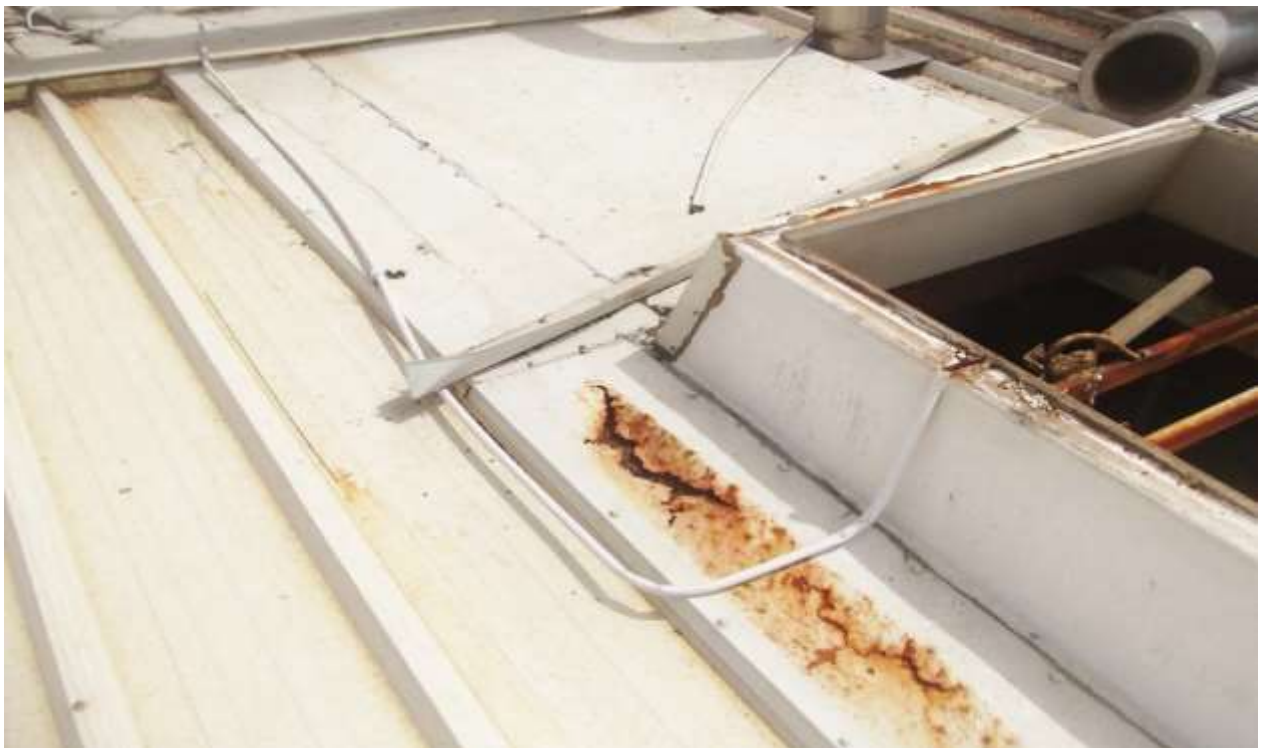
Fig. 10. Painted steel plates and rooflights were locally completely destroyed after 4 years on the Production Hall roof.

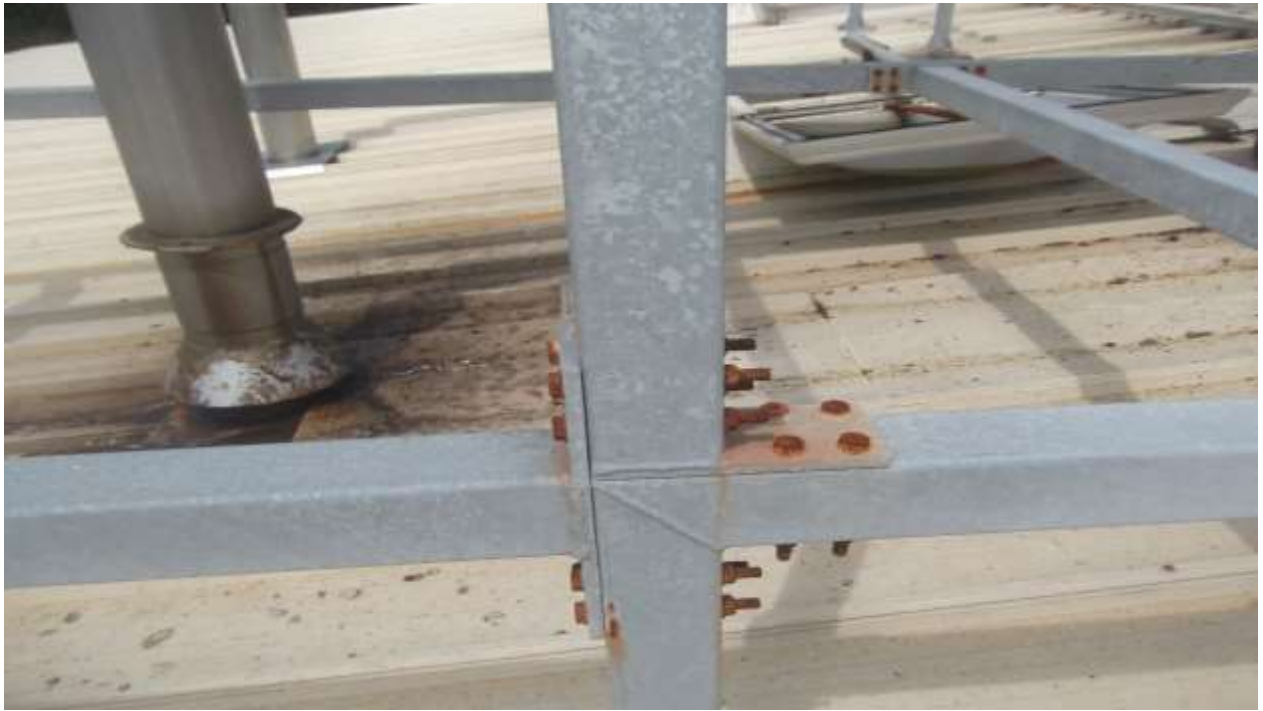
Fig. 11. Galvanized steel structures with no corrosion; steel screws covered completely with rust after 4 years on the Production Hall roof.

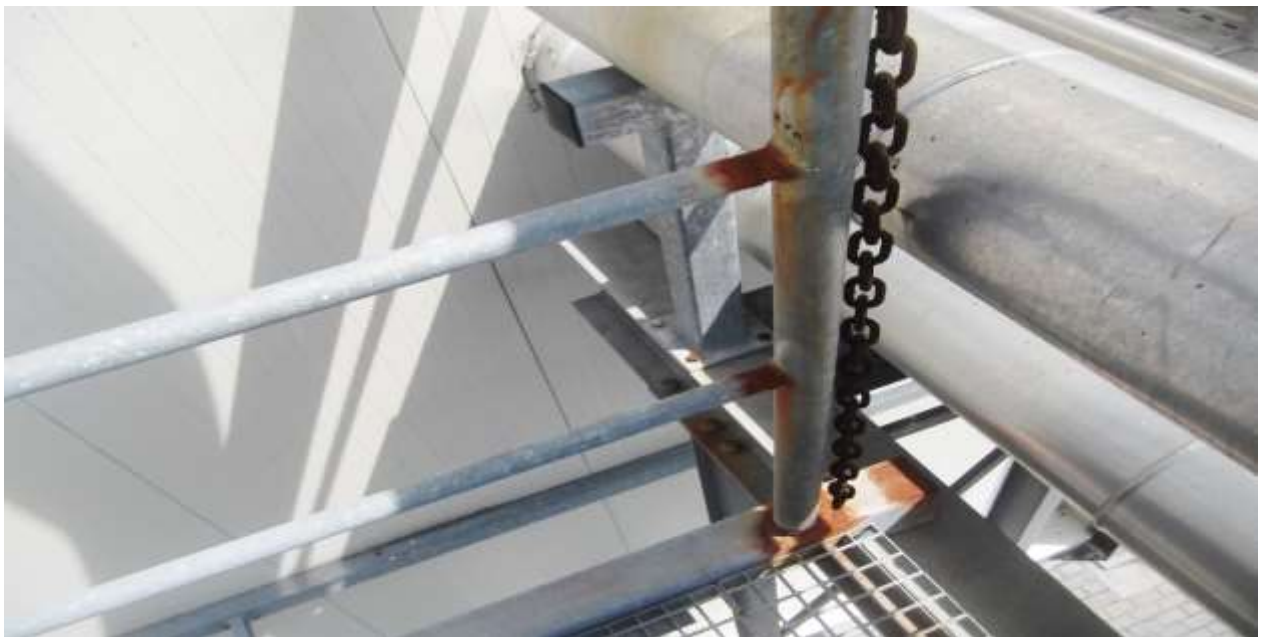
Fig. 12. External ladder steps corroded close to welds

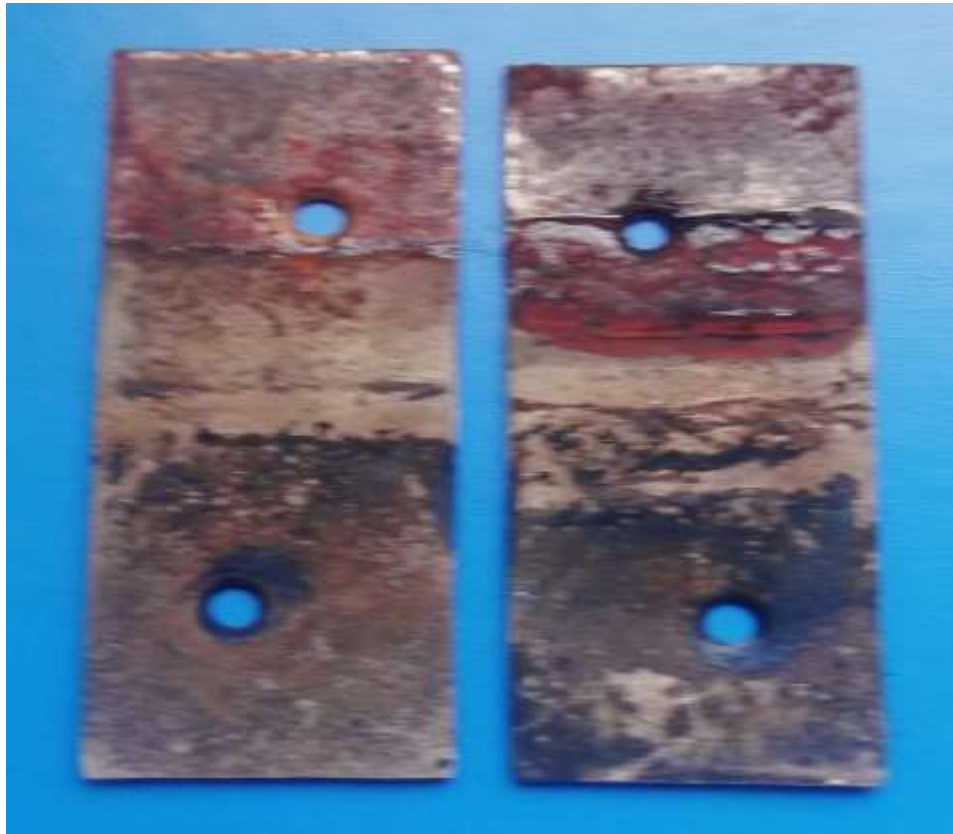
Fig. 13. Steel plates with lower part immersed in water saturated with poultry meal after 50 days exposure. The steel became rusted within vapours above the solution surface. Black deposit on the immersed part.

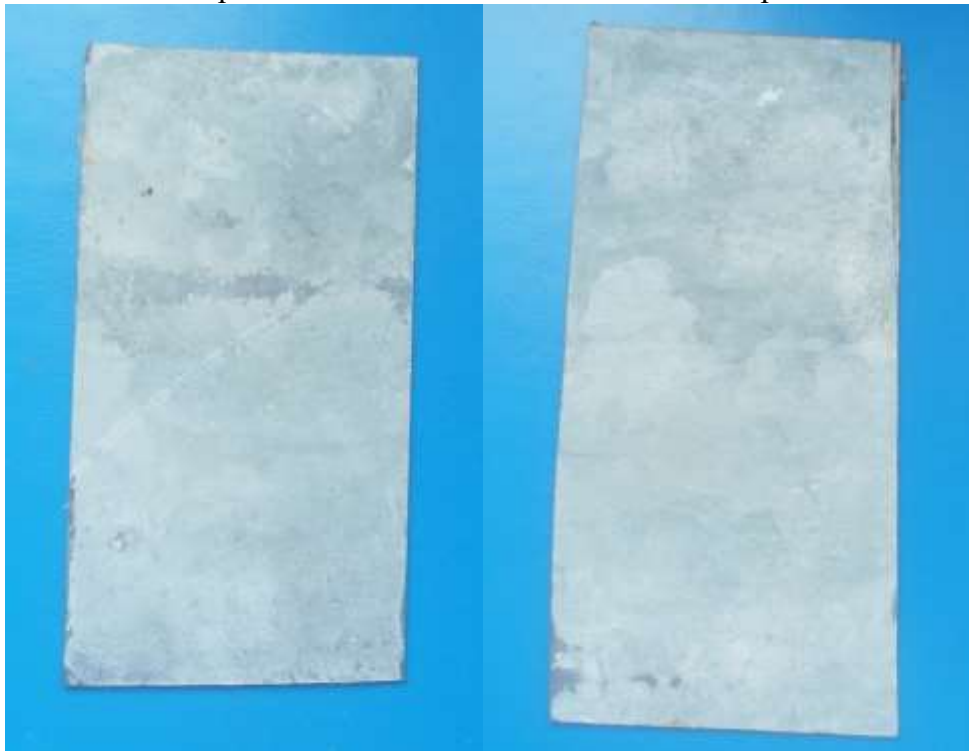
Fig. 14. Galvanized steel plates with lower part immersed in water saturated with poultry meal after 60 days exposure with no corrosion.
