- *Corrosion of galvanized air conditioning structures on building roof at coastal region*

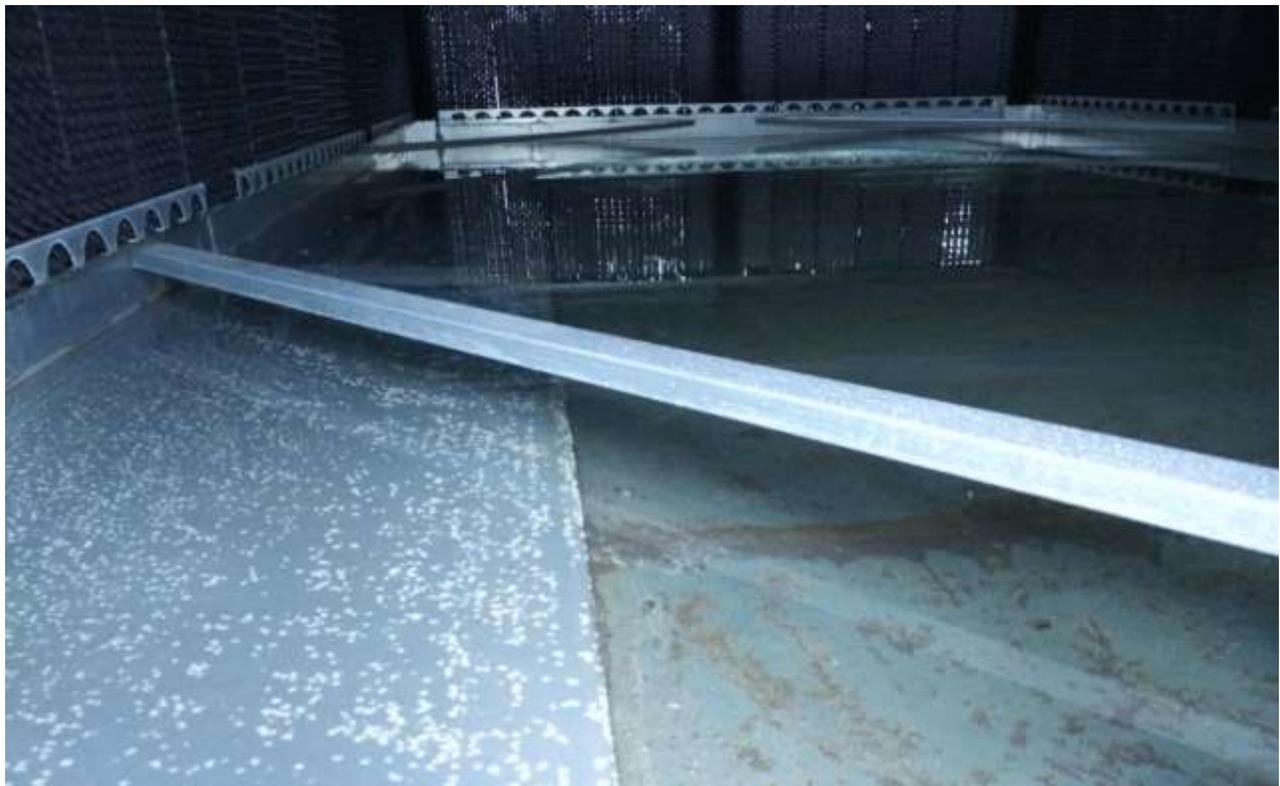
Chemical analysis of white rust sample taken from the tower interiors before starting of air conditioning determined over 25% of water soluble substances, composed nearly entirely of zinc chloride as a product of a chemical reaction. Because of very high zinc chloride solubility equal to 432g/100g at 25°C it accelerates galvanized coating damage. Most probably Dead Vistula river mouth with chloride concentration equal to 0,27-0,39 % was the main source of chloride salts. Corrosive aerosol containing chlorides was carried with winds from the sea direction and Dead Vistula situated around half a kilometer from the building.

Fig.1. White rust and iron oxides on galvanized coating of cooling water tank before air conditioning started work

It was advised to cover galvanized internal tower surface (except heat exchanger) with epoxy coating system durable in water containing chemicals at elevated temperature. The reason was high corrosion rate of zinc coating because of an atmospheric pollution with aggressive agents and periodical wetting and drying. In the case of heat exchanger damage it was advised to disassemble it and renew hot zinc coating to get an effective heat exchange. A possibility for application of another material solution was also mentioned.

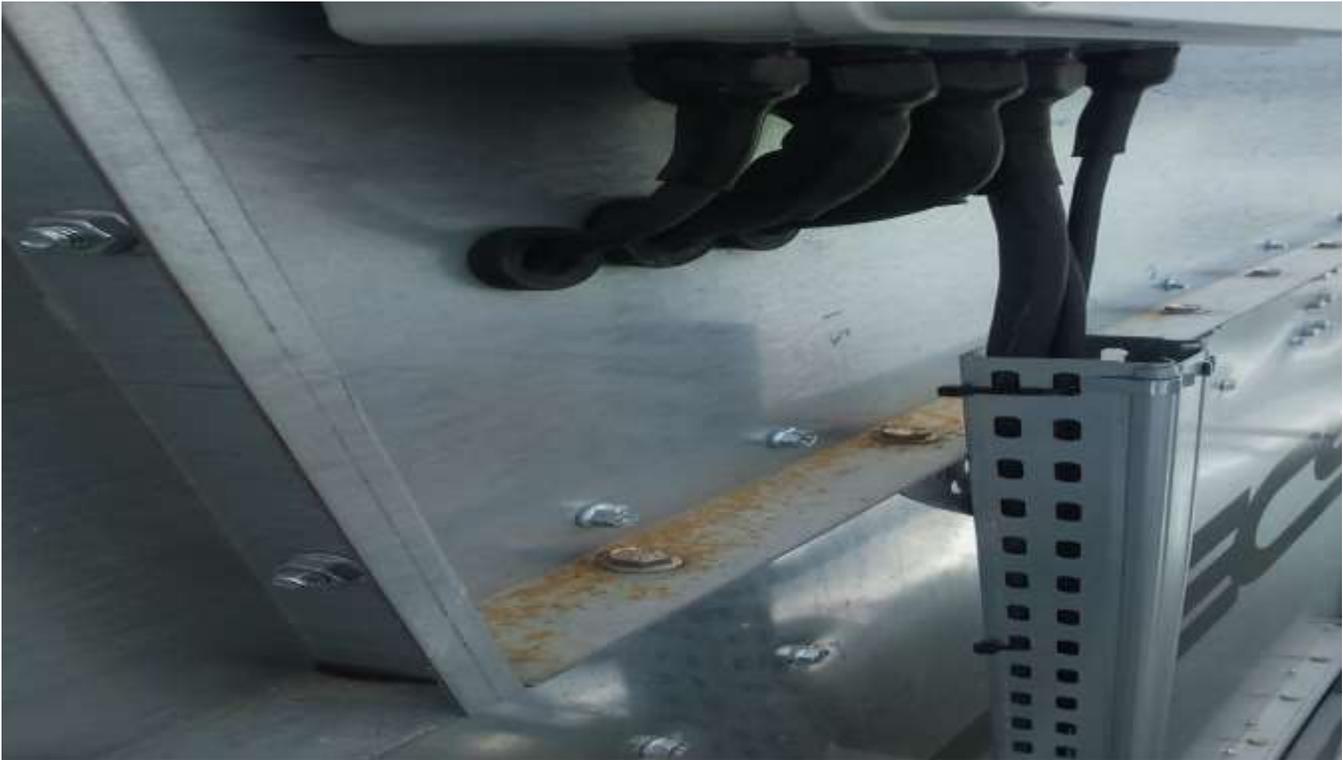
Fig.2. Iron oxides on the tower external surface in pores of galvanized coating after half a year of exposure at the building roof. The damaged coating on the rain collecting shelf was later, after cleaning, repaired with zinc rich paint

The zinc coating on external tower surface was in a good condition with expected sufficient thickness for several years of usage. A periodical coating control was advised because of existing corrosion threat. It was also advised to renew zinc coating with application of epoxy/poliurethane paint system in mthe case the damages are equal to Ri2/Ri3 patterns within the PN-EN ISO 4628 standard.

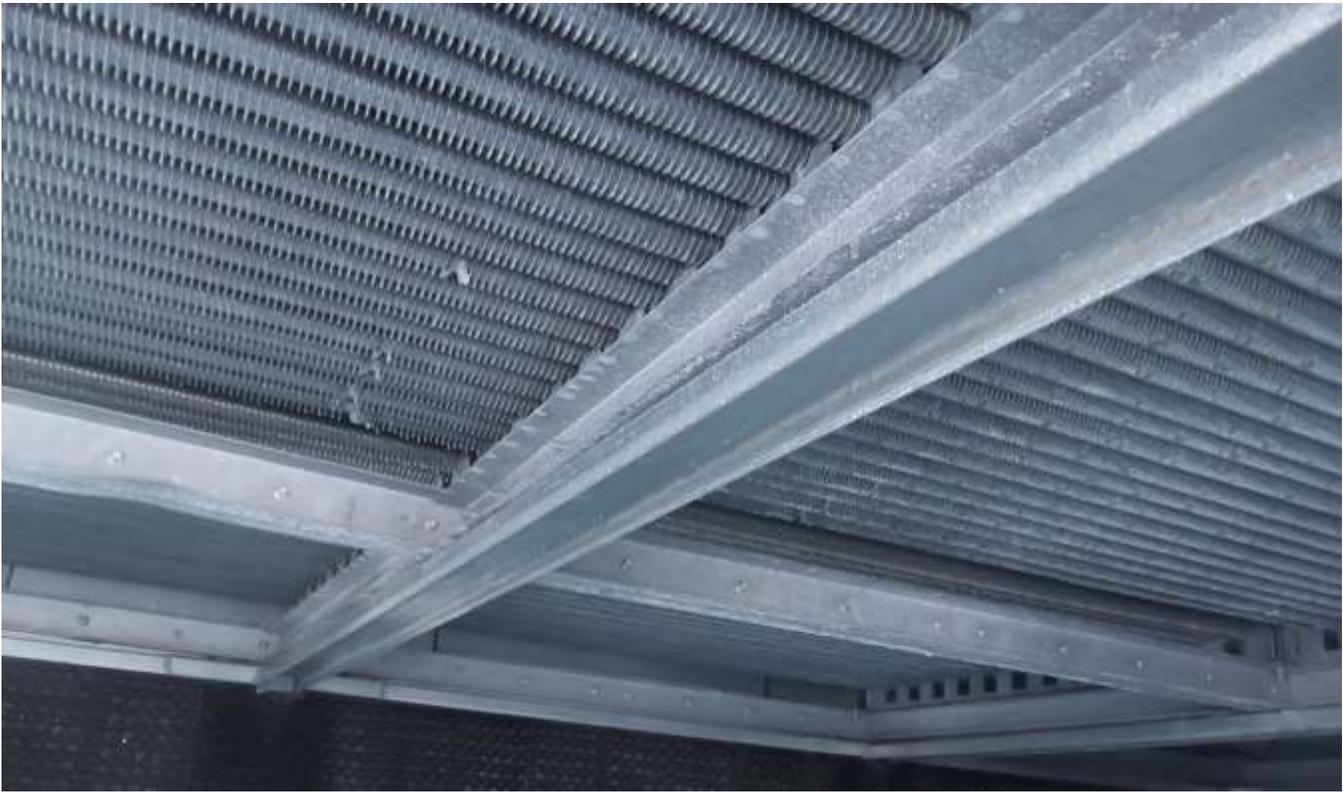
Fig.3. Deposit present on galvanized coating on heat exchanger after white rust removal, at the time of modified water application

After most of the deposit was removed by mechanical and chemical means, some needle pitting was locally present in the coating having thickness over 40 µm. At the pit bottoms was rust (iron oxides).

Water was modified with the aim to passivate zinc within the pH region of 7-8 by increasing hardness to produce a thin film of badly soluble phosphates and carbonates on the zinc surface.
