- *Evaluation of ice water aggregate condition*

Expert survey on an aggregate element condition was carried out with the aim to evaluate the range of defects and the reason that the unit has not been put into operation since the delivery time during over two years.

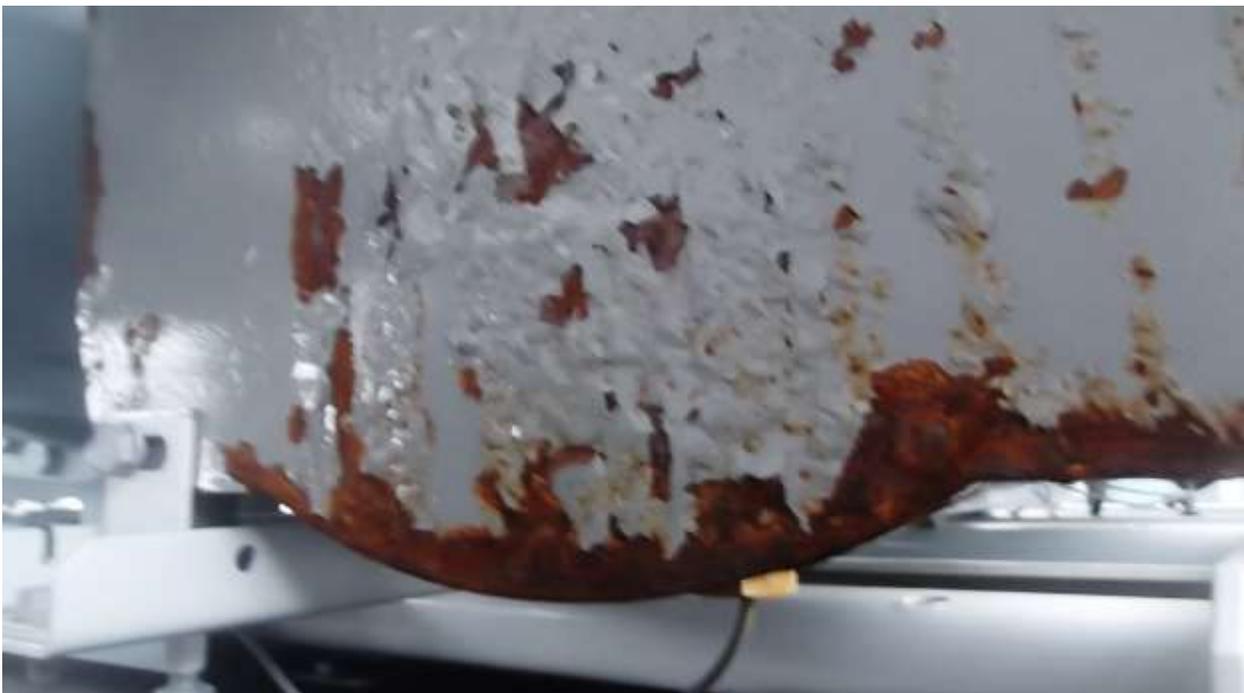
Particularly the oil separators were painted on much rusted surfaces (Fig. 1-2). Instead of using a proper anticorrosion paint system one layer of paint was applied. The paint film did not adsorb to the substrate, and was brittle so much, that its fragments were easily crushed into small pieces between fingers and the film could be easily removed from the substrate using just fingers. The paint coating was completely destroyed and the substrate so covered with rust that a conclusion could be drawn that two separators installed in the new aggregate were not new and were kept in aggressive atmosphere.

Fig. 1. Single paint coating on the oil separator was brittle and applied over rusted surface

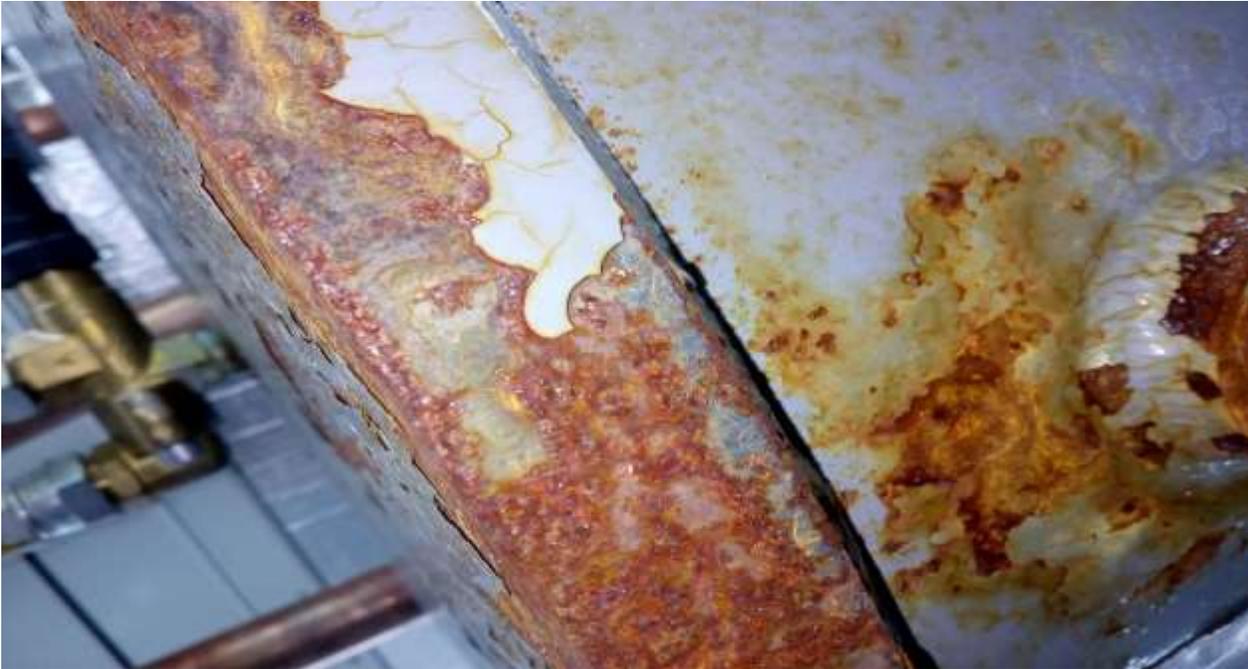
Fig. 2. Paint coating on the oil separator shows no adhesion to the rusted surface

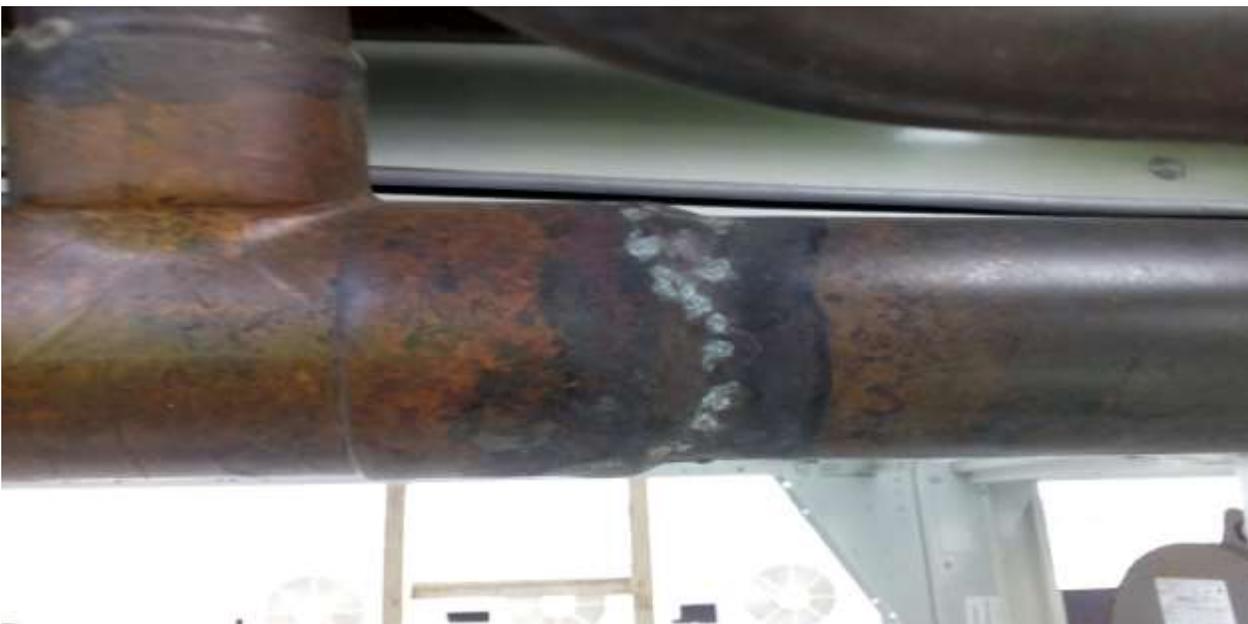
Most of the copper piping was covered with dark patina and locally had grey-greenish spots of copper corrosion products. Such type of surface conversion does not happen during typical transport or storing conditions. The condition of such pipes can be compared with some new copper pipes installed, which were not covered with patina (Fig. 3-5).

Fig. 3. Copper piping with corrosion spots

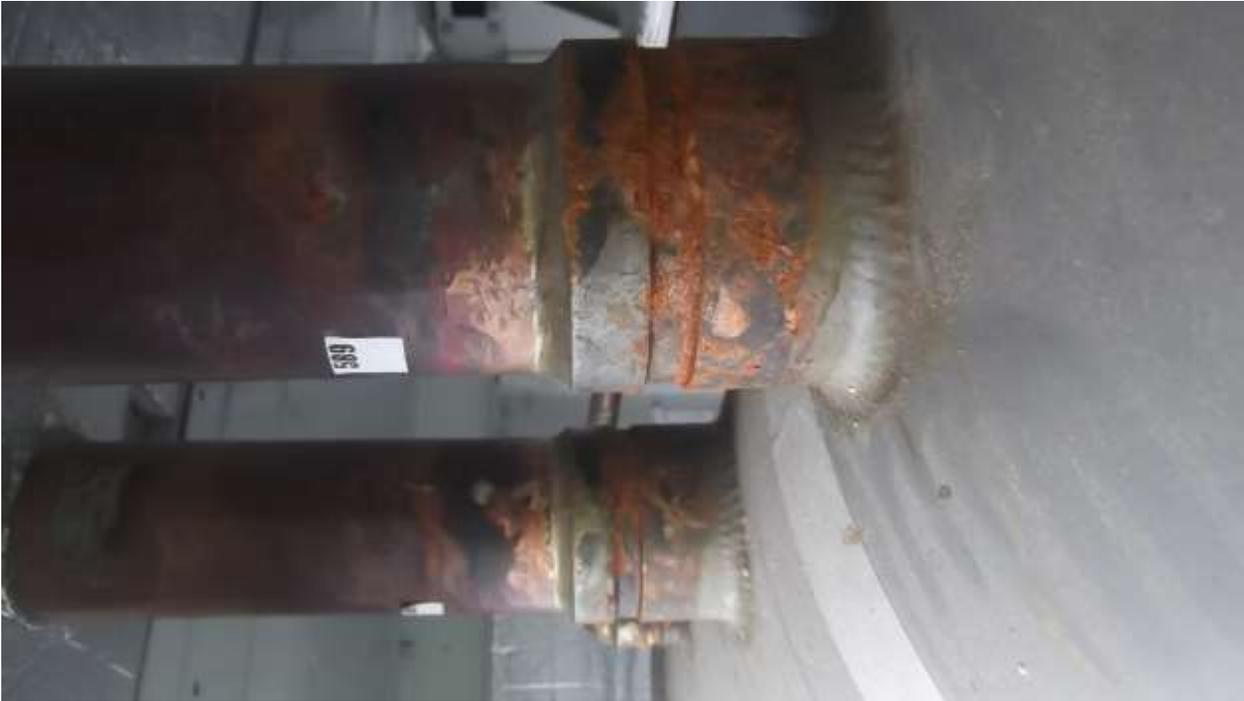
Fig. 4. The installed copper piping was not a new one

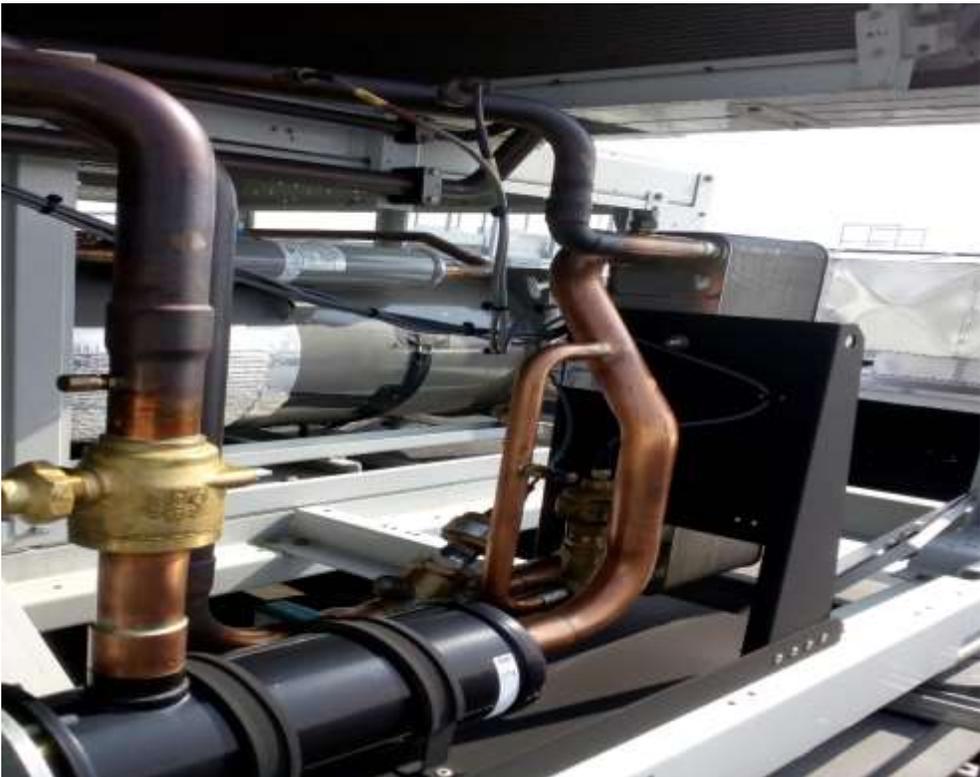
Fig. 5. New parts and old ones of installed copper piping

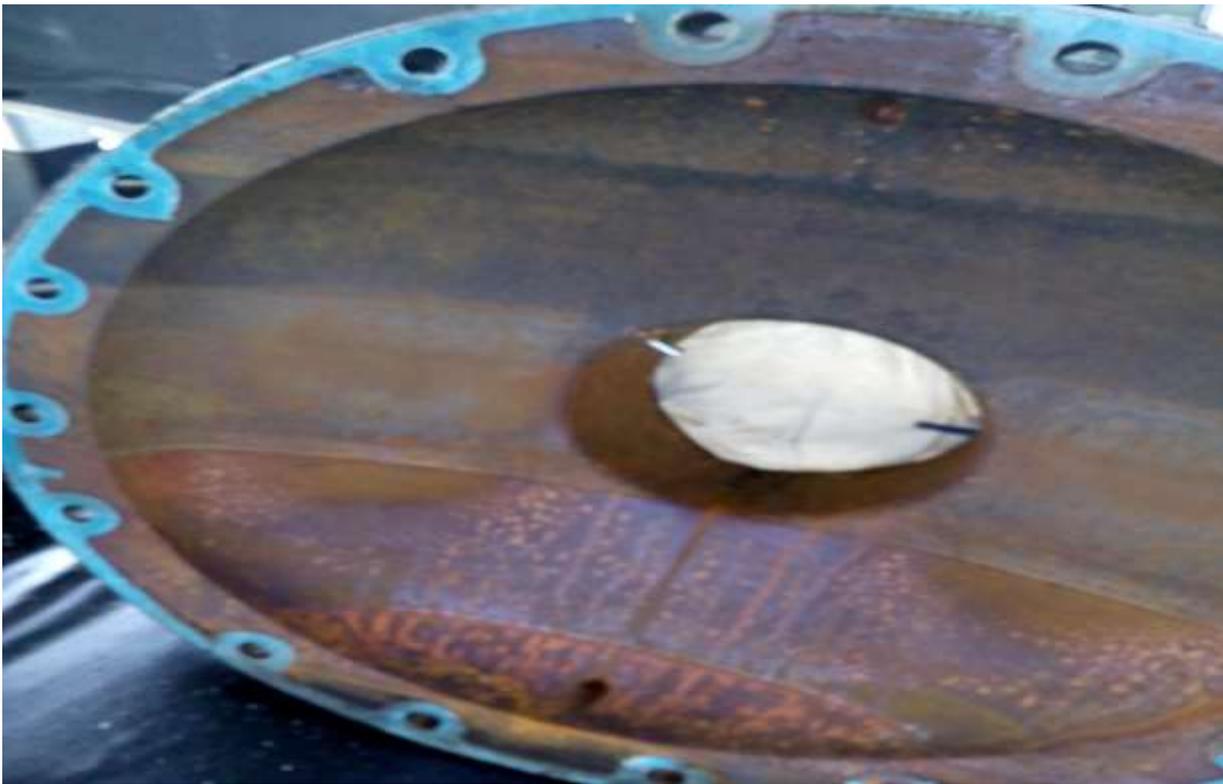
The source of the marks on the inside of heat exchanger (evaporator) showing different levels after filling with water was not exactly known (Fig. 6). Every of such linear trace was not left after very short filling with water, because it should be period of time long enough of reaction with cast iron surface to form intense corrosion products. The specialist service during the attempt to put the heat exchanger into operation estimated 80 tubes leaking and suggested their fracture due to low temperature (Fig. 7). During a review of registered temperature it was not possible to find enough low freezing temperature at the time the exchanger was filled with water.

Fig. 6. Heat exchanger cover showing several levels of water

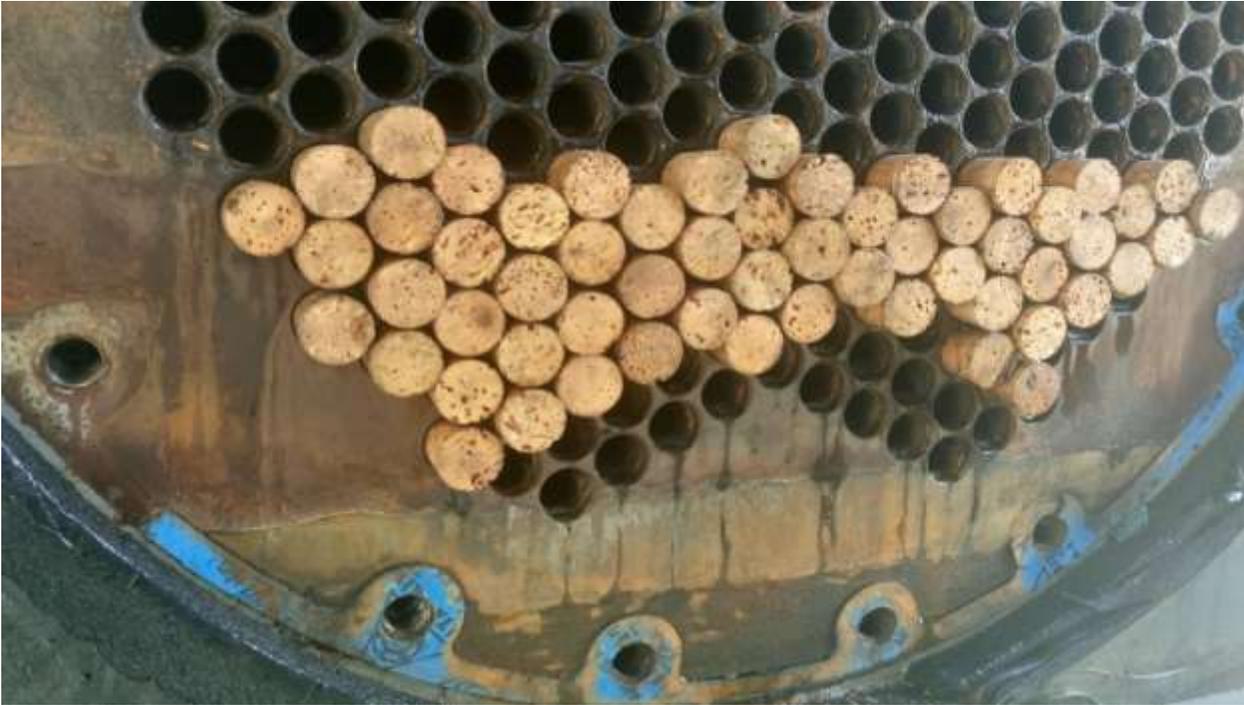
Fig. 7. Heat exchanger after tube tightness tests carried out by the specialist company

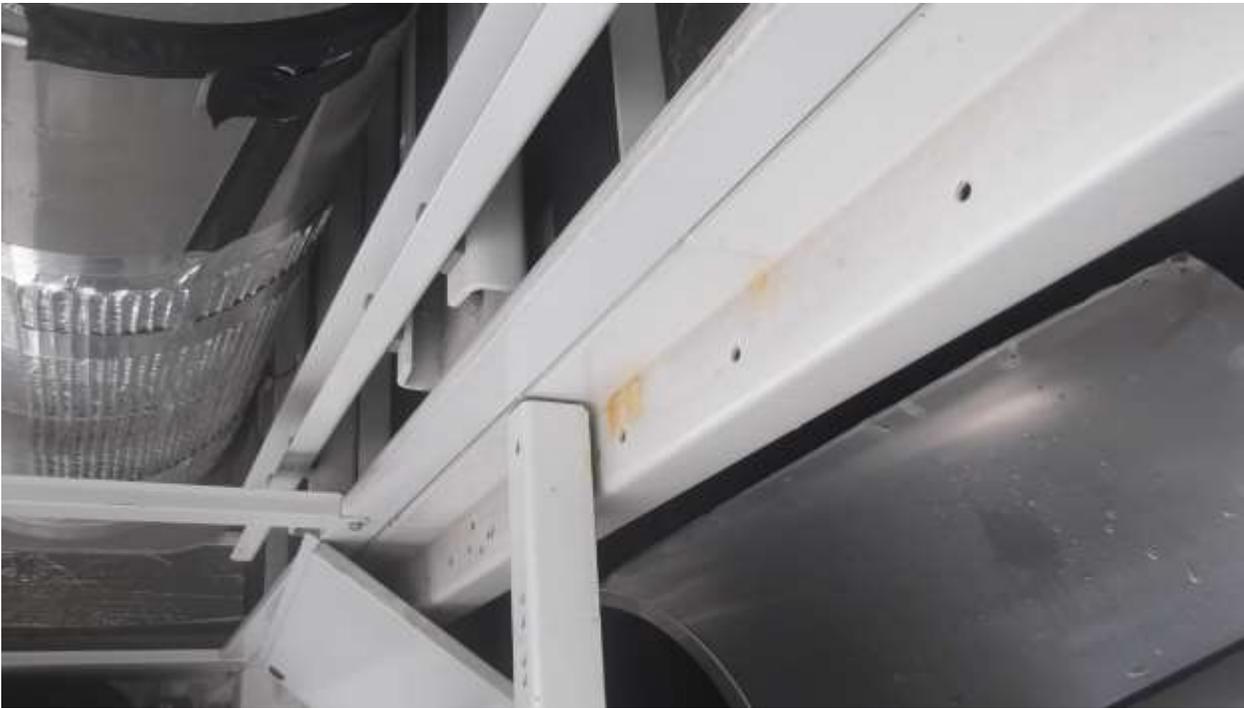
The light grey paint coating on the aggregate holding frame did not show any signs of destruction changes after two and a half years in atmospheric conditions, that proves its good quality.

Fig. 8. The light grey paint coating on the aggregate holding frame hard and elastic. Locally on a few points first signs of rusting after two and a half years in atmospheric conditions

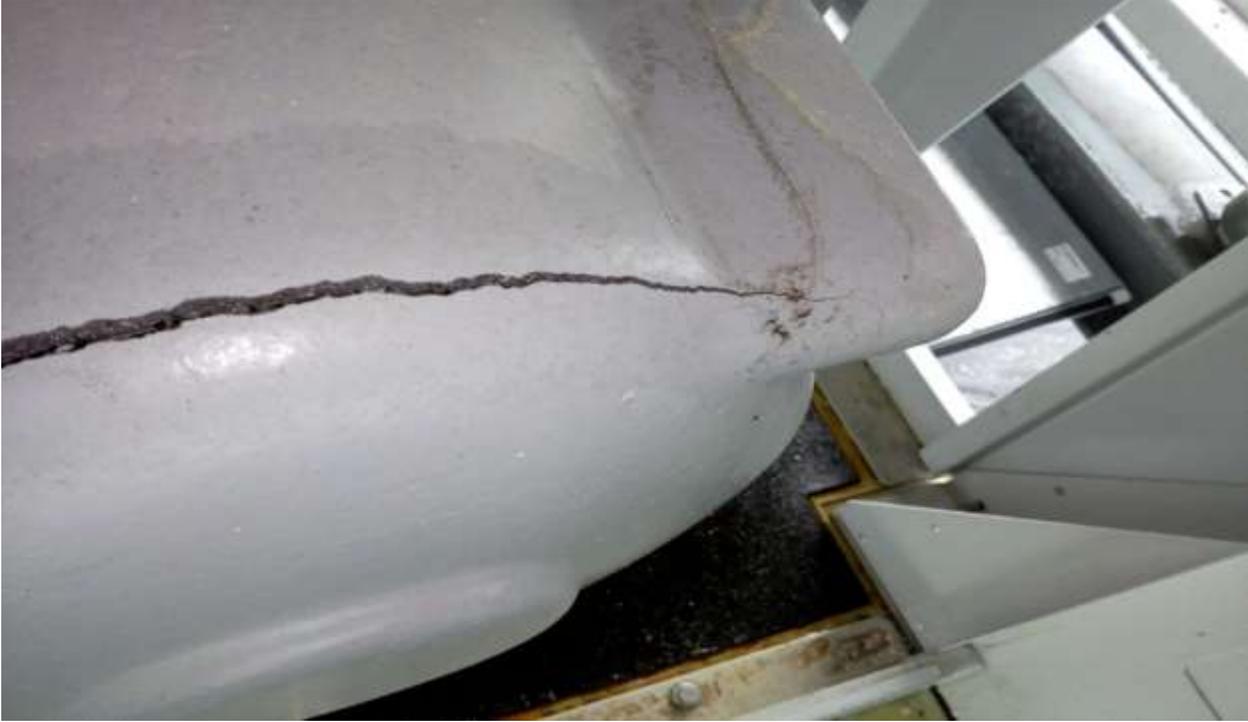
A circumferential fracture of the compressor cast iron wall was found after a few months from the attend to put the aggregate into operation (Fig. 8).

Fig. 9. Circumferential fracture of the compressor wall
