Pickling and Passivating of New built Huge Fleet of Chemical Tankers in Szczecin Nowa Ship Yard from 2002 till 2007

No 1/2008

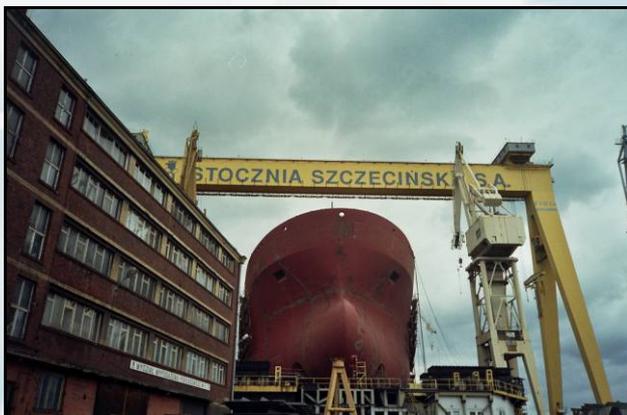
Fig. 1. Huge chemical vessel built in Szczecin shipyard

Ancora Co. signed contracts with Szczecin Shipyard (Fig.1) on cleaning, pickling and passivation of 8 huge chemical ships 40 000 dwt each with fully stainless steel tanks with pipeline systems, starting work from the second part of 2002 (Fig. 2).

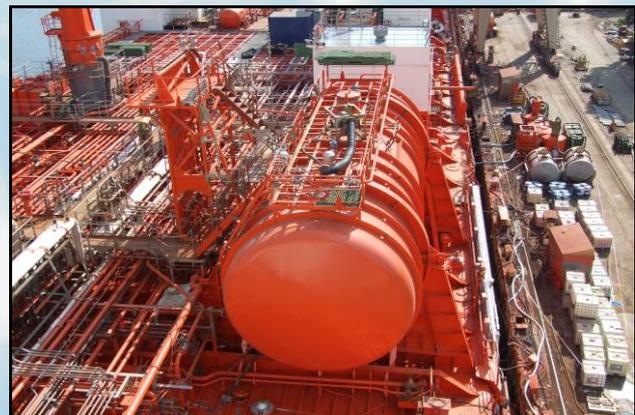
Fig. 3. Slope tanks located over the board

The owner of the tankers was Odfjell SE - Odfjell Seachem AS from Norway. These ships with tanks and systems made of duplex stainless steel represent the highest level of flexibility yet to be built.. Each of the ships has 40 cargo tanks, 6 slope tanks (Fig.3) and adequate pipeline systems for filling and emptying cargo tanks, for ventilation and

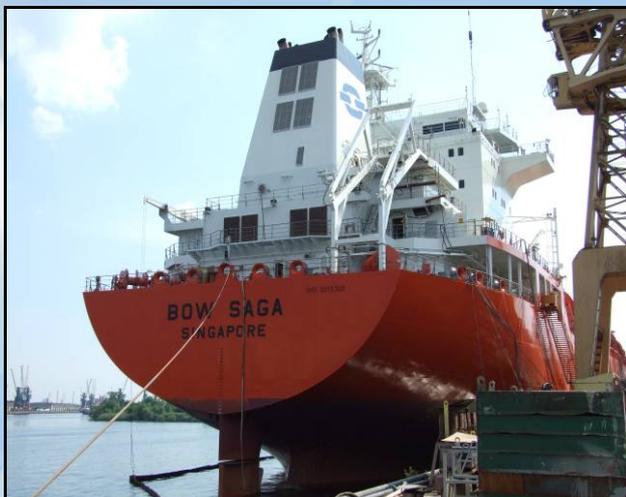
Fig. 2. The latest tanker from the series at Szczecin Nowa Ship Yard

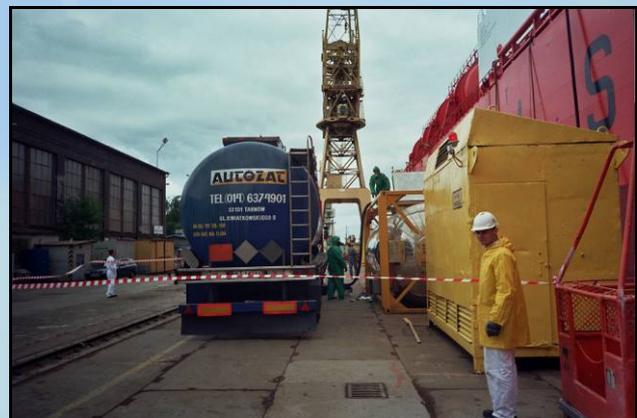
Fig. 4. Chemicals for passivation delivered in cisterns

filling with inert gas. The surface for passivation was extremely large so that required huge quantities of chemicals. These were delivered in road cisterns straight from producers (Fig.4) but also in IBC containers (Fig.5).

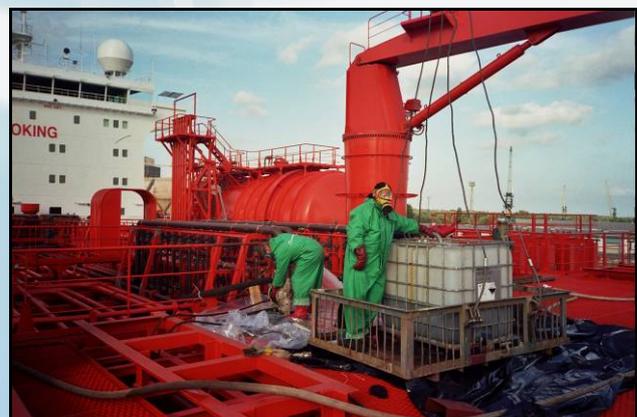
Fig. 5. Chemicals for passivation delivered on the tanker board

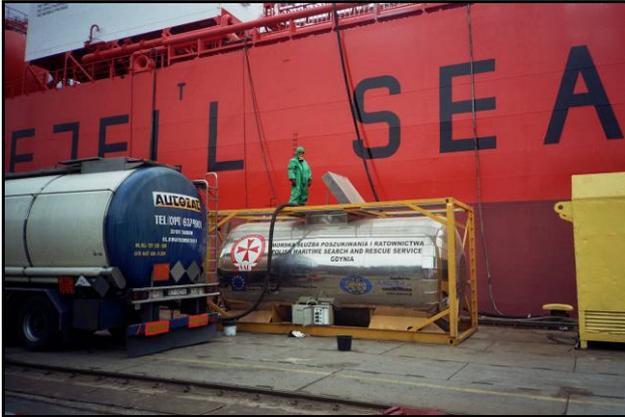
Fig. 6. Chemicals prepared at the landing pier

The chemicals were diluted, mixed or neutralized in a container built by the Ancora Co. with the primary purpose to carry port chemicals (Fig.6).

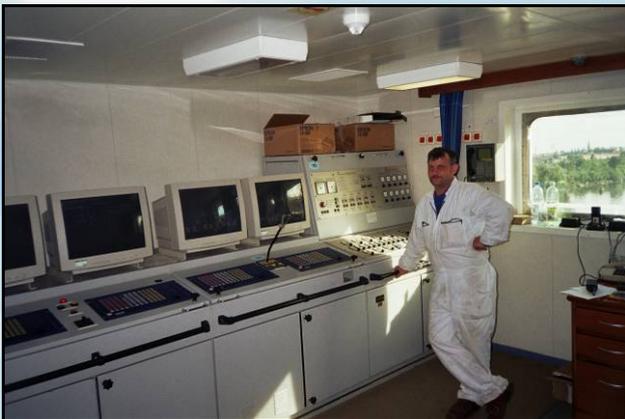
Fig. 7. Room for automatic control of transported and sprayed chemical

A specific procedure for cleaning, pickling and passivation of each system was presented to the shipyard and the owner representatives and was accepted by the supervisors of each side. The proposed system for the tanks was to spray the chemicals, water and finally demineralized water using automatic tank washing system. The system allowed governing all the technological steps from the control room (Fig. 7) including loading, unloading, pumping, opening or closing valves etc.

Electronic control made possible to read volume of chemicals, to guide their transport by operating valves, to put into operation (rotation and up and down

movement) of scan jet spraying nozzles, precisely controlling time of each operation.

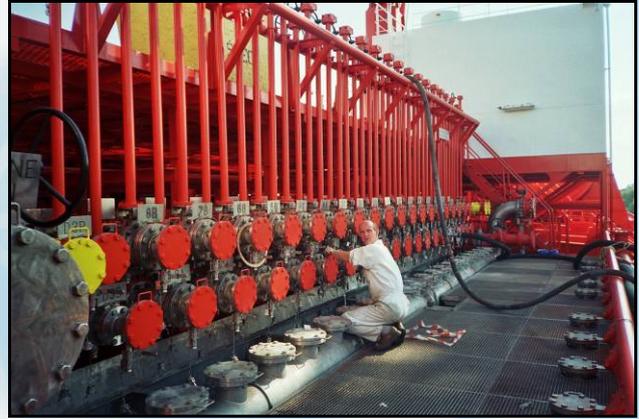
Fig. 8. Flexible temporary connections started from manifold

Each of the chemicals were pumped from one tank to another consecutively using ship pumps after making out flexible temporary connections of the cargo systems with the cleaning systems at the manifold (Fig.8).

After making temporary connections the systems were checked for tightness using water under pressure. There was around 50 m³ of each chemical liquid circulating from the loading systems to the cleaning systems and flushing the tank walls. After the circulation in one tank was over the medium was pumped to the next tank, and a new circulation between cargo system and the washing system started without a delay. Simultaneously a cleaning operations, pickling and passivation were carried out in the maximum number of tank systems. Demineralized water was produced by each of the ship to cover the demands for final cleanings.
