• *Corrosion of stainless steel elements in swimming pool building and method for improving construction durability*

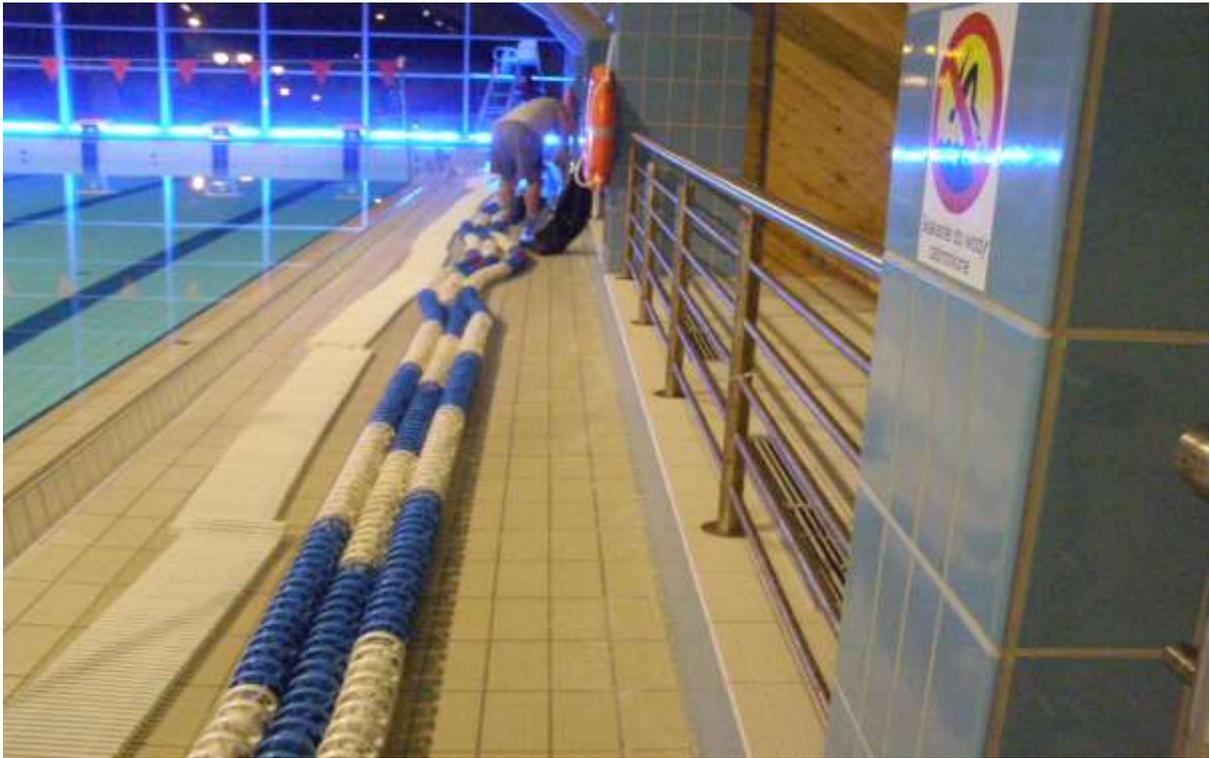
Corrosion progress on railings made from the 316Ti (1.4571) and balcony cover plates made from 316L (1.4404) stainless steels in the swimming pool building appeared in the first month of usage. Corrosion was induced by hot air coming from the outlets of ventilation canal situated at the floor behind pool railings (Fig.1) and by salt aerosol deposition. Particles of aerosol carried by air stream into the ventilation inlets situated on the other pool side under the roof were deposited on stainless steel railings and plates (Fig. 2). Hot air coming from the ventilation increased rate of water evaporation from the railings and plates resulting corrosion agents concentration increase, up to the level at which stainless steel lost its resistance against pitting corrosion. High humidity at the pool surrounding was supporting corrosion process in spite of multiple air exchange.

Fig.1. Warm air coming into the building interior from the ventilation canal at the floor effected corrosion of 316Ti stainless steel barriers

Other construction materials having high corrosion resistance against chlorides or alternative protection with paint coating having easily renewable outer layer were proposed to improve durability of the structures.

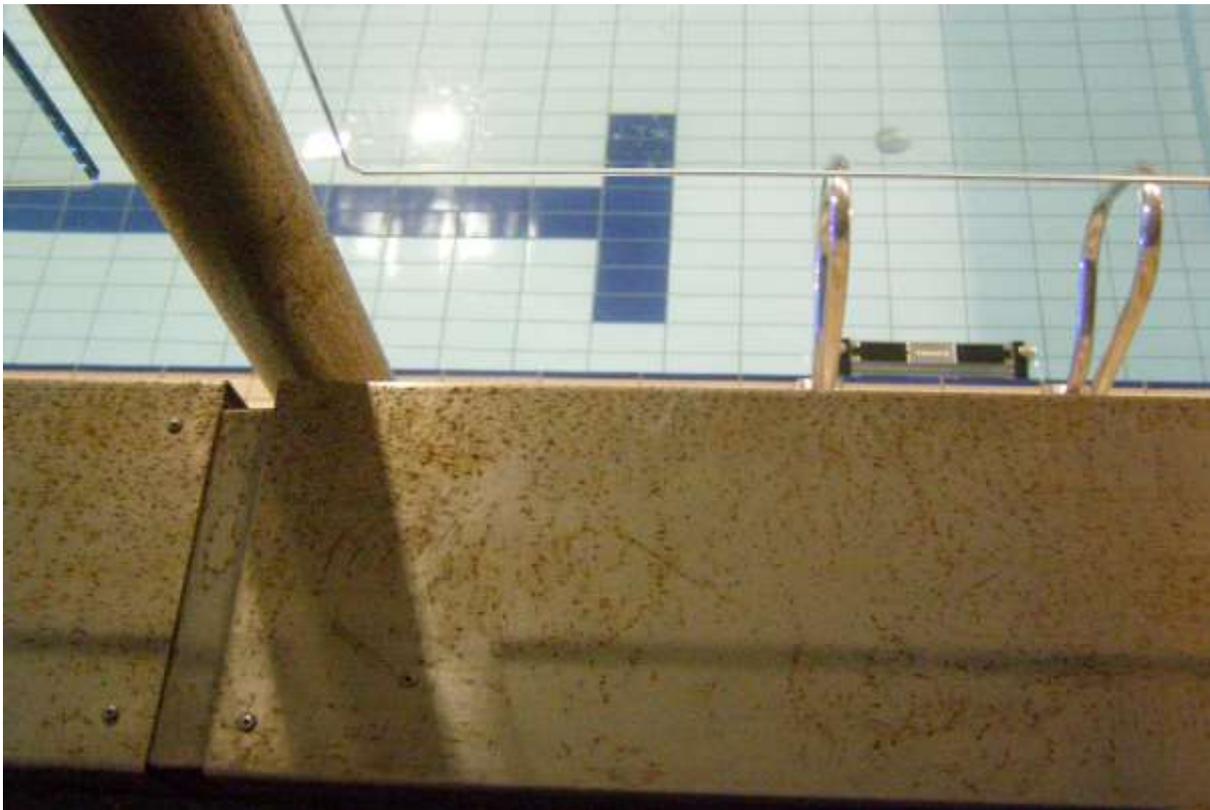
Chlorine compounds that react with decomposition products of urea and creatinine introduced with human sweat and urine to water form volatile chloramines that have disinfection properties. Water aerosol with chlorides, hypochlorous acid, hypochlorous acid anions and chloramines creates very aggressive corrosion atmosphere that effects pitting corrosion of stainless steels. Intensity of stainless steel pitting corrosion is proportional to the concentration of chlorine compounds. To inhibit corrosion of metal constructions in natatoria stainless steels must be regularly flashed with water to prevent increase of solution concentration that effects corrosion. This necessary condition was completely impracticable within the pool building.

Fig.2. Aerosol of chlorine compounds carried by air stream to the ventilation air exits effected corrosion of stainless steel plates and railings at the terrace

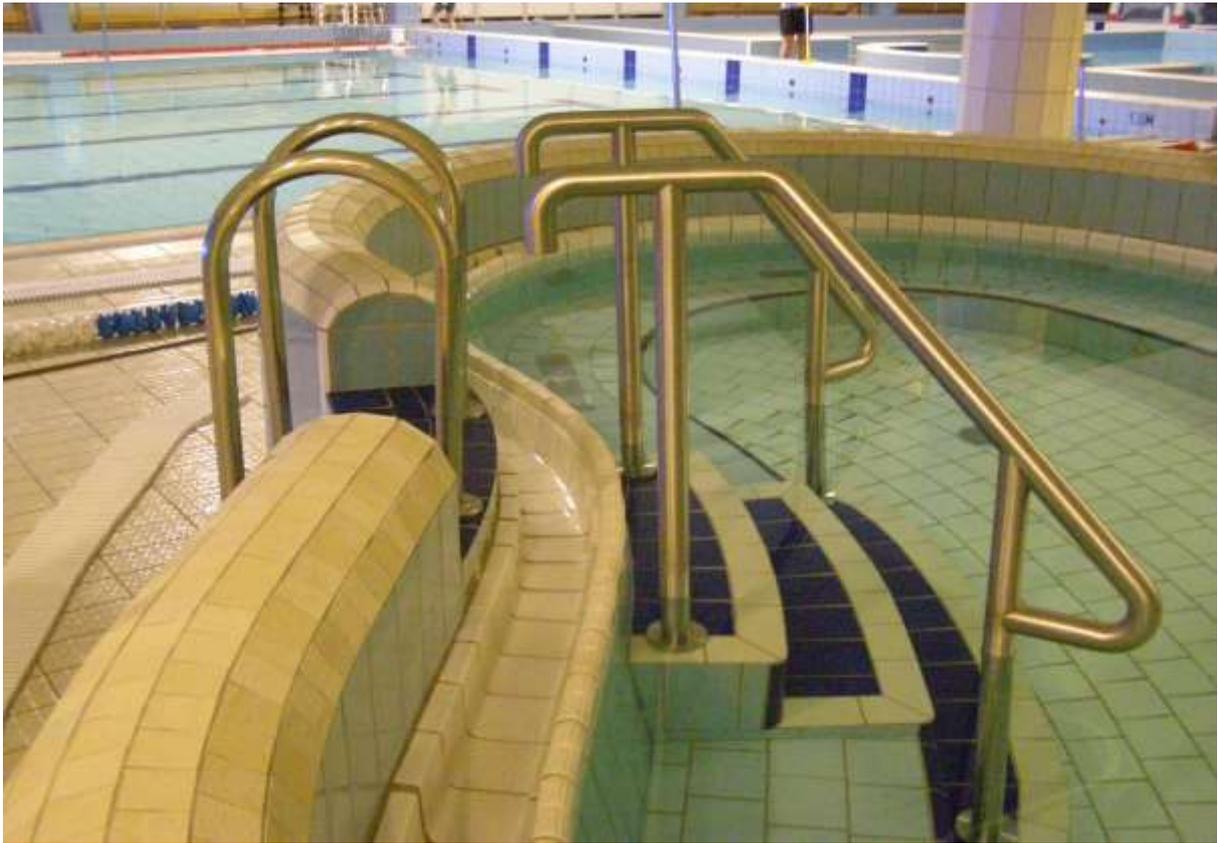
Fig.3. 316L stainless steel railings situated out of the air streams washed every day did not show any corrosion signs
