Pickling and Passivating of Corroded Tanks on Chemical Ship

No 4/2011

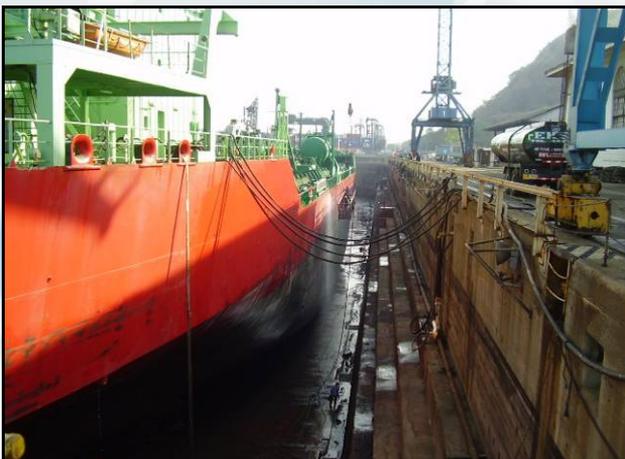
Fig. 6. The tanker in Braswell International S.A Shipyard in Panama

An action on rust removal was undertaken by ANCORA Co. five years after the tanker was constructed. The pickling/passivation work by Ancora Co. was done in the Astilleros Braswell International S.A Shipyard in Panama (Fig. 6.) during general repair period.

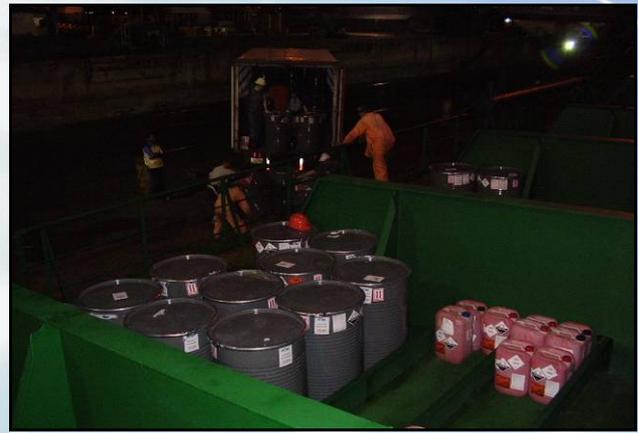
Fig. 7. Chemicals for cleaning, pickling and passivation delivered from Avesta Co. by air

The cleaning and pickling/passivation were performed by hand spraying of Avesta Welding chemicals transported from the producer in Sweden by air (Fig. 7).
