## CHEMICAL TREATMENT OF WATER/STEAM SIDE OF WASTE TO ENERGY INCINERATORS

No 7/2015

Preoperational chemical treatment of water/steam side of 2 incinerators was performed for the Plant for Thermal Treatment of Municipal Wastes for Bydgoszcz – Toruń Metropolitan Region, Bydgoszcz, Poland. The work was done to the order of Sices Pensotti FCL in Legnano, Italy, subcontractor to Thermomeccanica Ecologia S.p.A. and Astaldi S.p.A., Rome, Italy. The work was performed by Ancora in cooperation with Vecom, Maassluis, the Netherlands and Marcor Jan Marjanowski, Gdańsk. Chemical treatment of the boilers including waste water neutralization and waste utilization was carried out during the time from 25.06.2015 to 17.07.2015. The work preparation was supervised by the Central Laboratory of the Polish Office for Technical Control (OTC) the institution that obligatorily inspects chemical treatment of the pressure vessels. Both Ancora Co. and Marcor have authorization from OTC to perform chemical cleaning of boilers. The cleaning technology that was applied was complying the documents: Aster Astaldi, TME, Technical Specification for Chemical Treatment and VGB PowerTech Guideline for Internal Clean

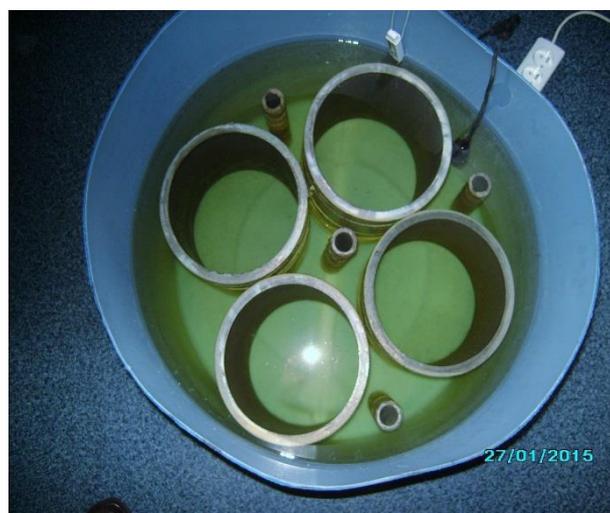
Pre-engineering work consisted of the project of chemical treatment technology for the incinerators that included designing of connection schemes and supporting installation montage. Laboratory tests were conducted to control pickling parameters and corrosion inhibitor efficiency with application of tube samples prepared from steels used for construction of the incinerators (Fig.1).

Fig.1. Pre-engineering laboratory testing of treatment parameters

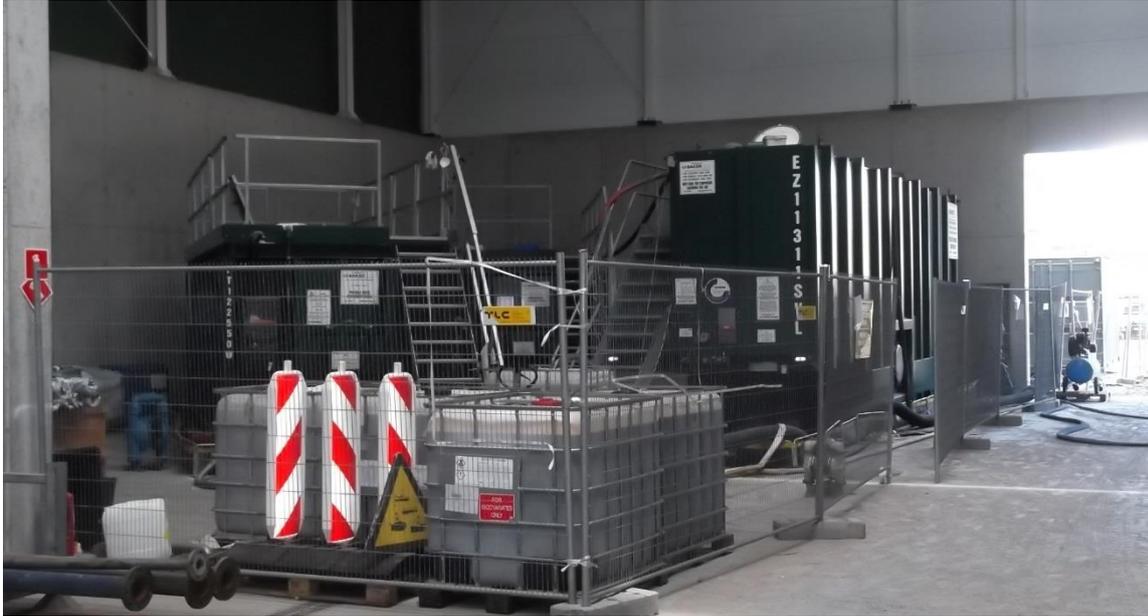
Construction of temporary circuits started after collection of storage and circulation tanks (Fig.2),

Fig.2. Storage and circulation tanks containers for temporary laboratory and office, pumps, pipes, steam generator (Fig.3), fittings,

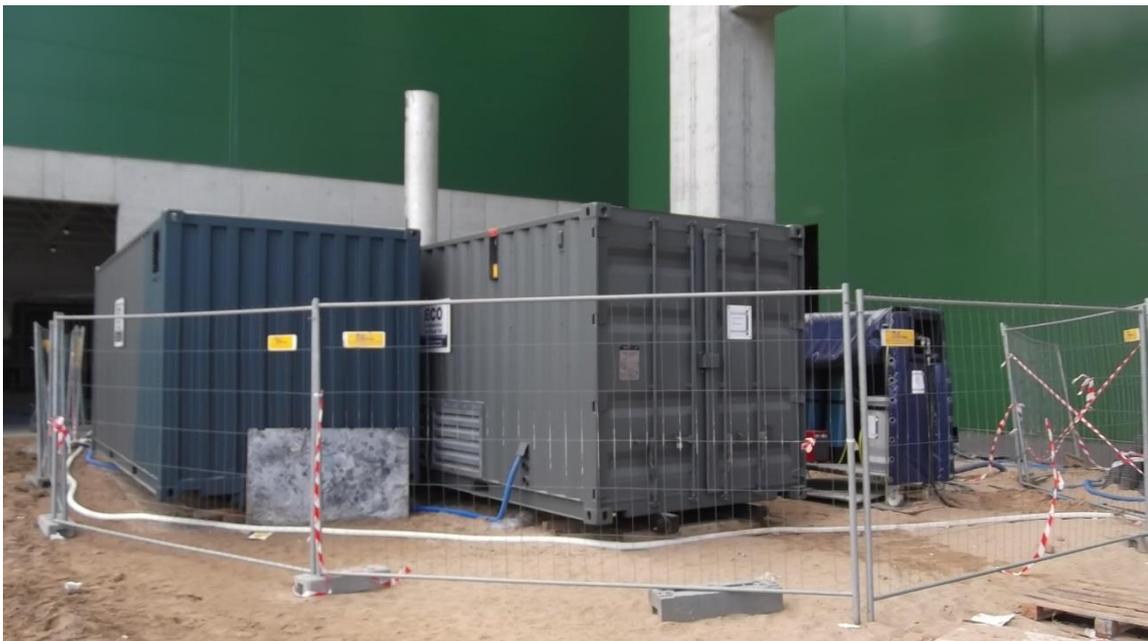
Fig.3. Steam generator with fuel tank

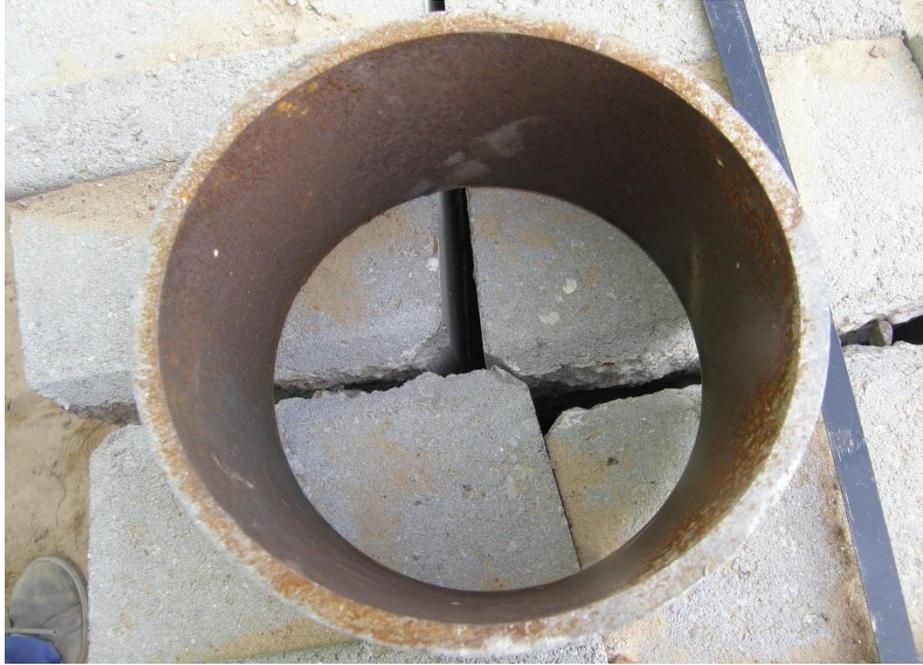
Fig.4. Sample before cleaning

and chemicals. After each boiler pre-flushing to remove non adhering contaminations and to check leak tightness, the boilers were degreased with slightly alkaline solution containing wetting agent, and flushed. Marchery Nagel tests performed did not discover any fatty contaminants. Then pickling by circulation of inhibited hydrofluoric acid at elevated temperature was carried out with analytical spectral control of acid concentration, pH, iron in the solution, and corrosion inhibitor test. Complete removal of scale and rust was confirmed by parallel testing of samples inserted into circulation tank within the circuit (Fig.4-5).

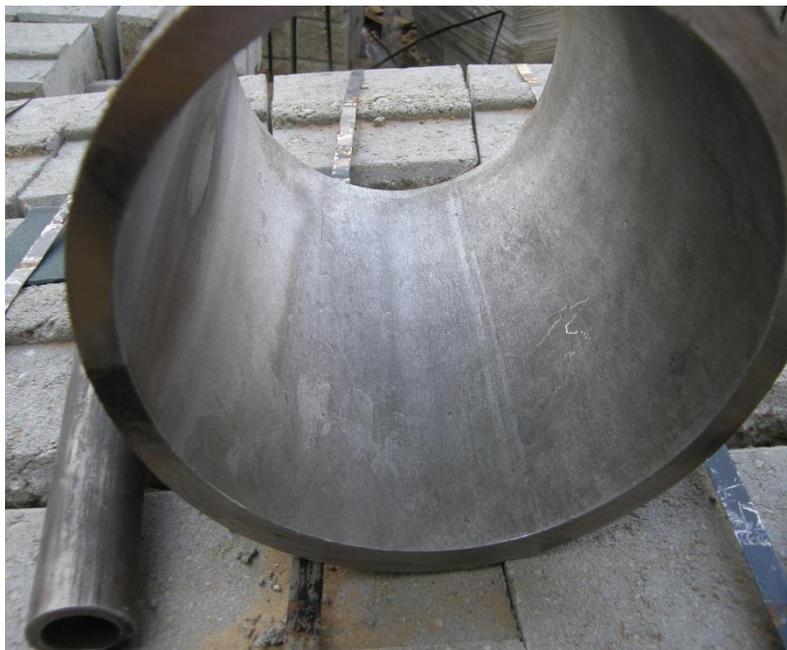
Fig.5. Sample after cleaning

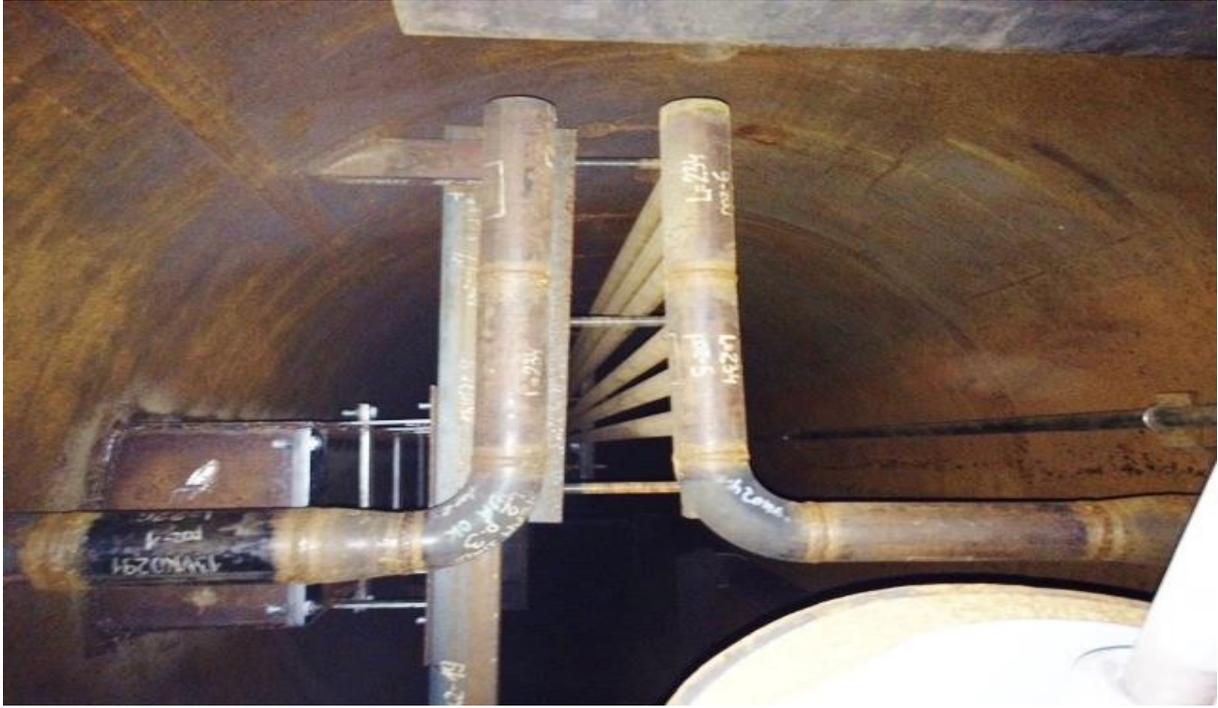
Fig.6. Incinerator interior before cleaning

When very clean metallic surface was obtained it was passivated in a slightly alkaline solution at elevated temperature until metal electrochemical potential change was of a remarkable value. The redox potential was regularly measured during the passivation step. A proper cleanliness was obtained so that the formation of a protective layer containing mainly magnetite was possible. The observations performed in the drum, at feed water inlet and the preheater showed that the steel was uniformly, superficially pickled (Fig.6-7).

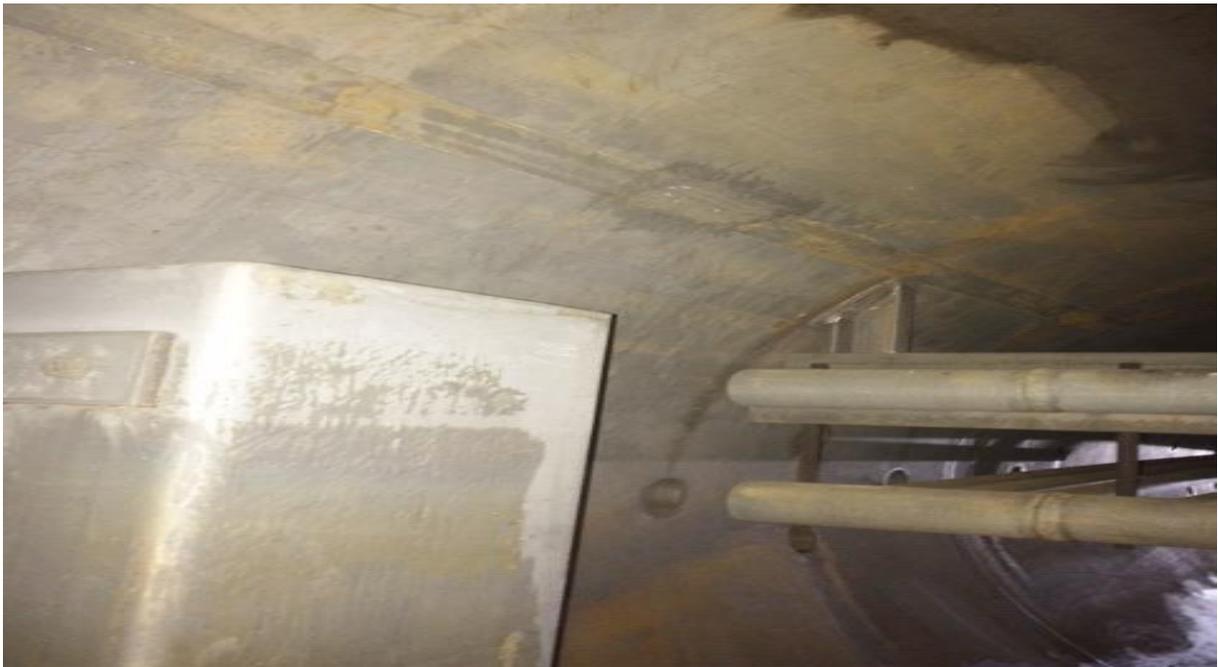
Fig.7. Incinerator interior after cleaning

The contaminations coming from the construction time, mill scale and rust were removed leaving incinerator passive surface over water-steam side. After work control and its full acceptance, both incinerators were hand over to the client in a very proper condition. On such technically favorable basis an operation of the steam turbine must be very successful. The temporary circuit was disassembled, equipment and not used up chemicals were evacuated.
